**VCU**

**September 2023**

# Pedestrian Safety Study

## Potential Improvements and Recommendations

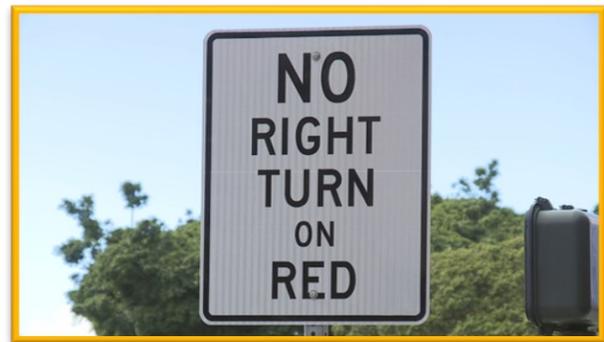
No Turn on Red signage is a relatively low-cost safety treatment that reduces potential conflicts between pedestrians and vehicles turning right (or left) at a red light. The implementation of No Turn on Red signage should be based on sight distance, estimated number of pedestrian conflicts with turn-on-red vehicular maneuvers, estimated turn-on-red crashes, and guidance provided in the Federal Highway Administration's Manual on Uniform Traffic Control Devices (MUTCD). Locations

depicted in **Exhibit 1** are recommended for evaluation for installing No Turn on Red signs.

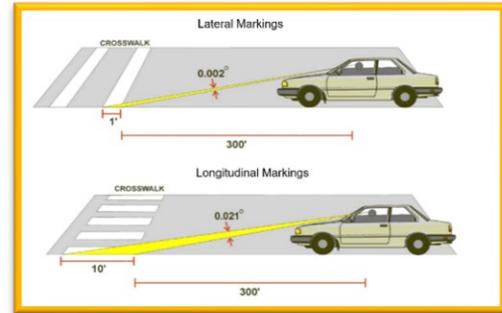
Longitudinal crosswalk markings are white longitudinal lines parallel to traffic flow. When longitudinal lines are used to mark a crosswalk, the lateral crosswalk lines may be omitted. Longitudinal crosswalk markings have higher visibility than lateral crosswalk, improving visibility of the crossing to motorists and pedestrians. Locations where crosswalk marking upgrades are recommended are depicted in **Exhibit 2**.

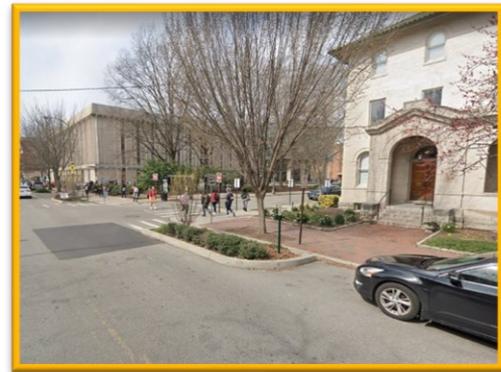
Curb extensions are used to tighten the physical geometry of an intersection, thereby forcing motorists to drive more deliberate paths through the intersection and reduce their speeds. Curb extensions also shorten the pedestrian crossing distance and time required to cross the street. It is recommended that curb extensions be installed on one or both sides of an intersection approach. Curb extensions can be built with paint, bollards, planters, or concrete. Locations where curb extensions are recommended are depicted in **Exhibit 2**.

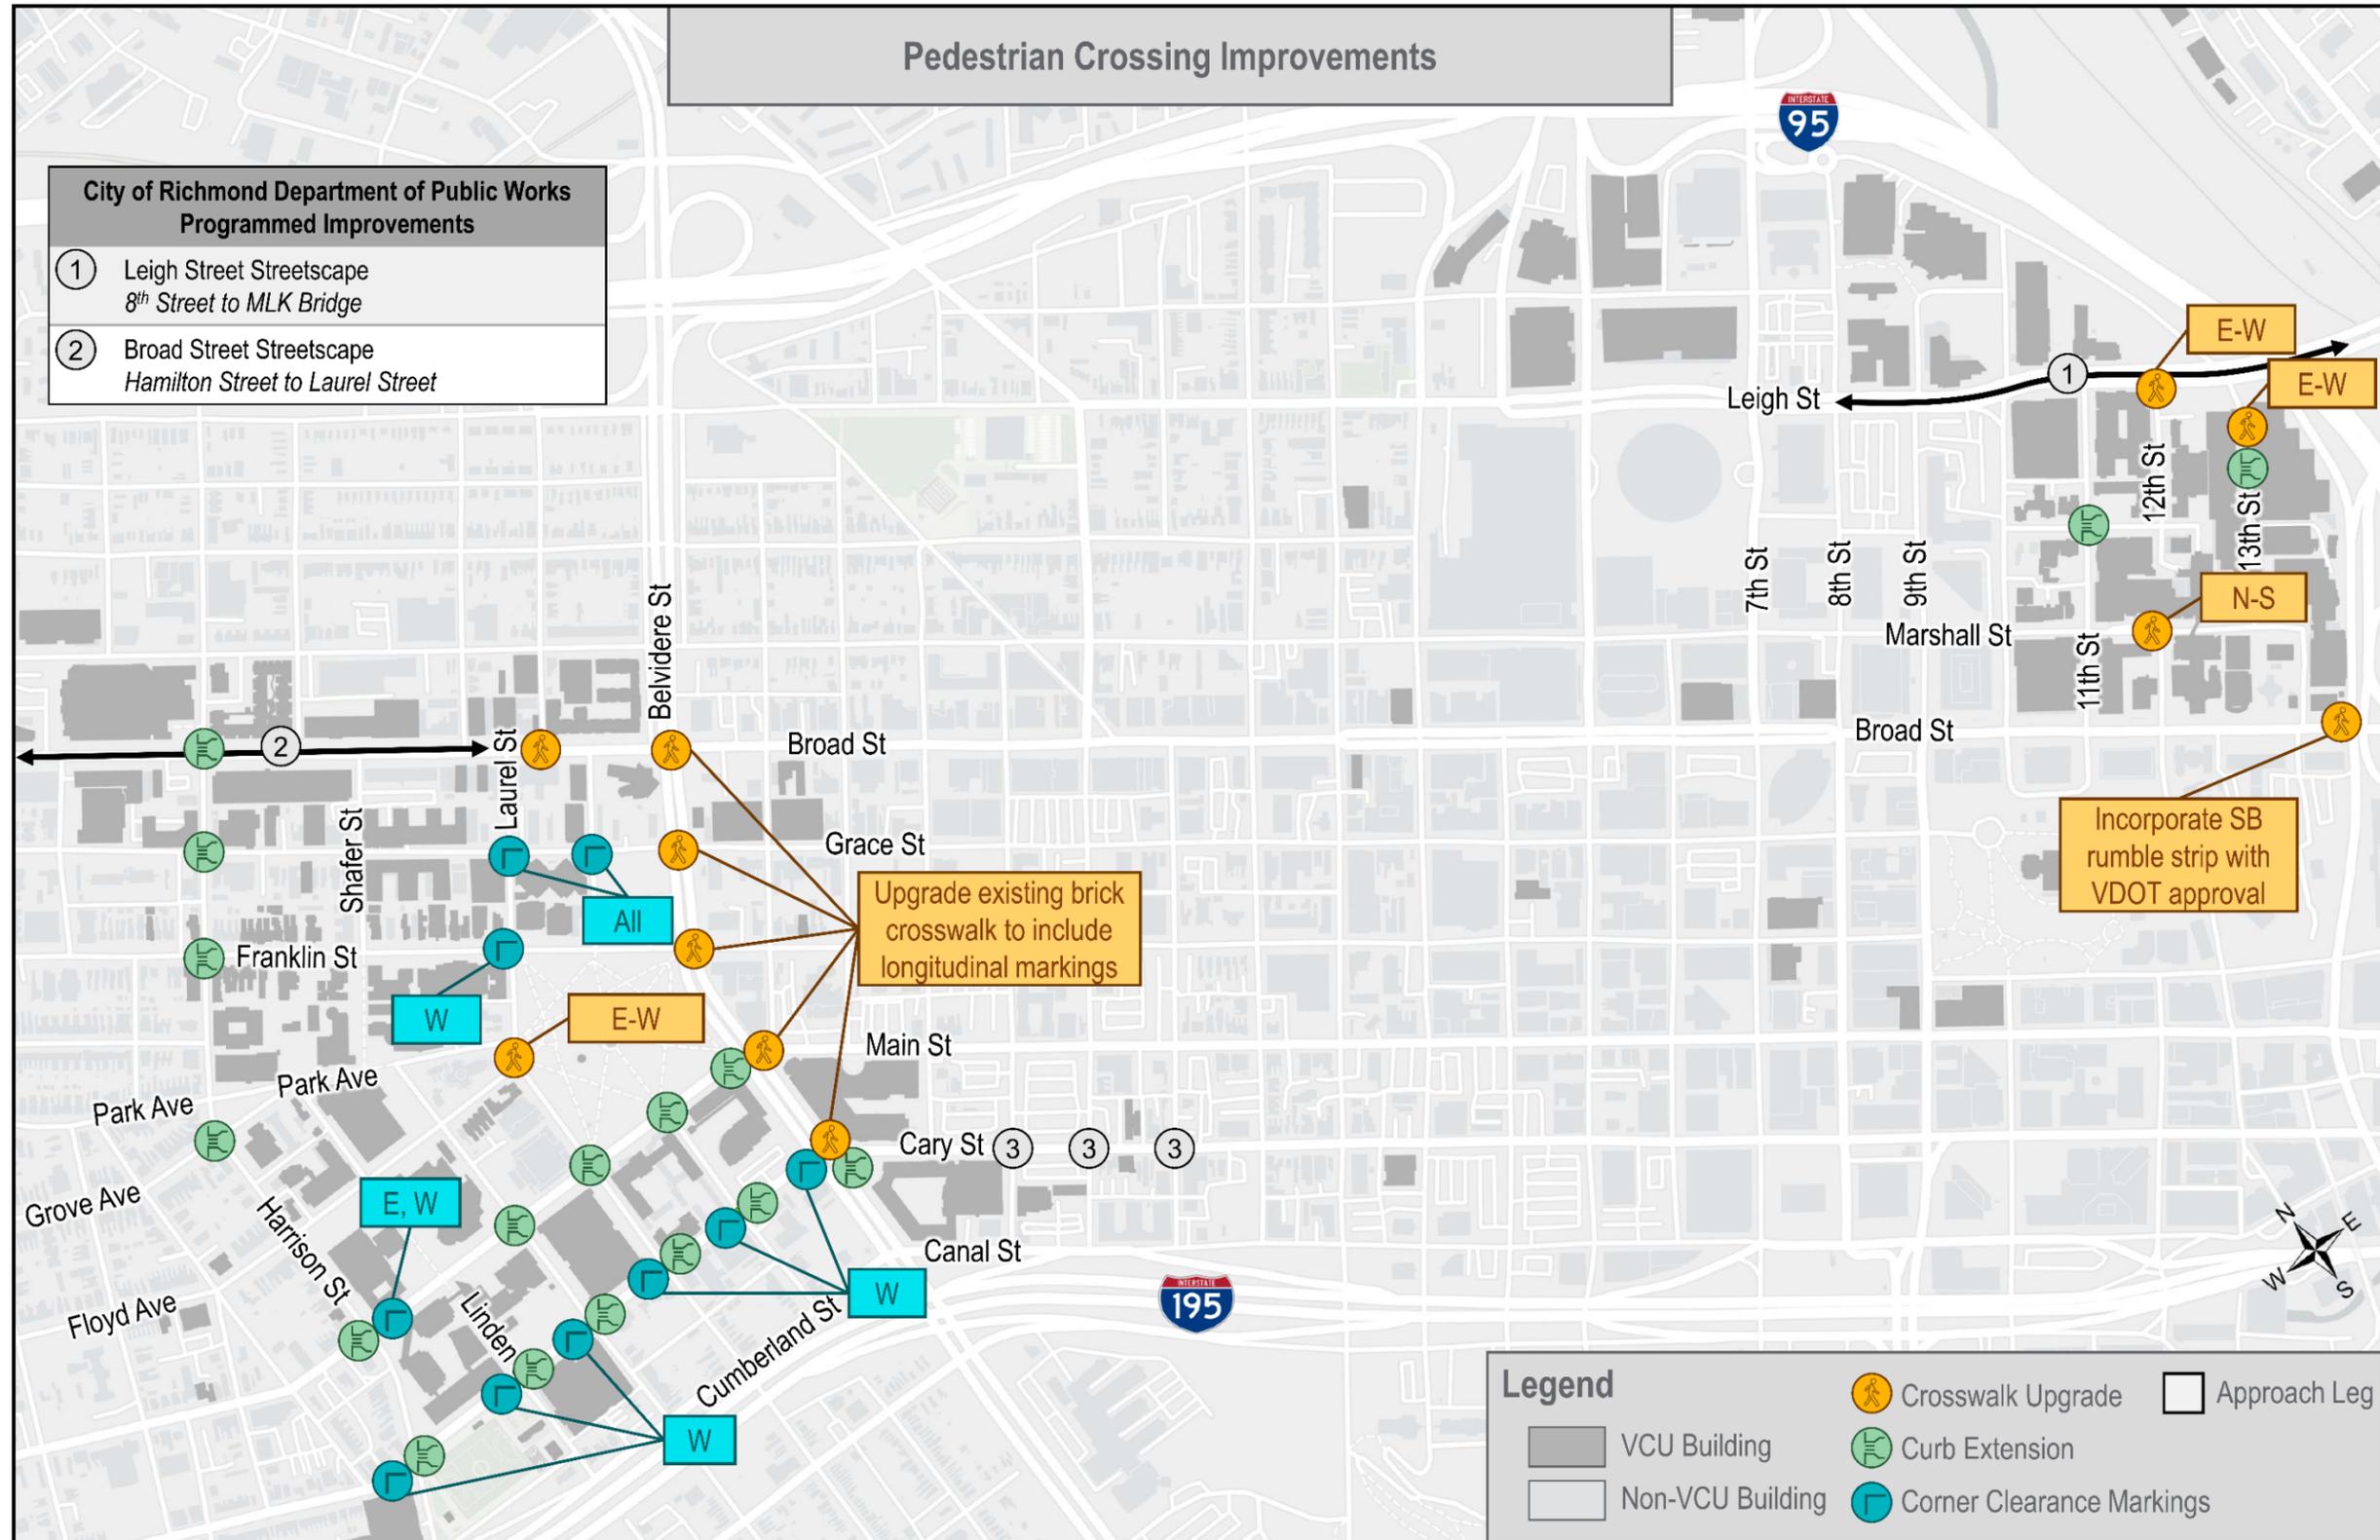
Exhibit 2: Pedestrian Crossing Improvements

Corner clearance markings are physical markings and/or signed restrictions that eliminate on-street parking and loading spaces within 20 to 25 feet of a pedestrian crossing. Corner clearance markings, also known as daylighting, increase the visibility between pedestrians and vehicles thereby reducing potential conflicts and increasing safety. Locations depicted in **Exhibit 2** are recommended for evaluation for installing corner clearance markings.

- The City will replace existing brick crosswalks containing lateral markings along Belvidere Street with high-visibility longitudinal crosswalk markings. Funding is secured for fiscal years 2025 – 2027.

- The City will complete crosswalk upgrades on 12<sup>th</sup> Street as part of a planned repaving project planned for Fall 2023.
- The City will use existing funding to implement the recommended curb extensions at the intersections of Pine Street with Main Street and with Cary Street.

- VCU will engage a consultant to design the other recommended curb extensions.
- VCU will relocate and improve two existing crosswalks and install curb extensions along 13<sup>th</sup> Street near D-Deck.

- The City will complete corner clearance markings in Fall 2023.
- The City is working on the Leigh Street Streetscape and Broad Street Streetscape projects, which include improvements to pedestrian infrastructure and crossings.

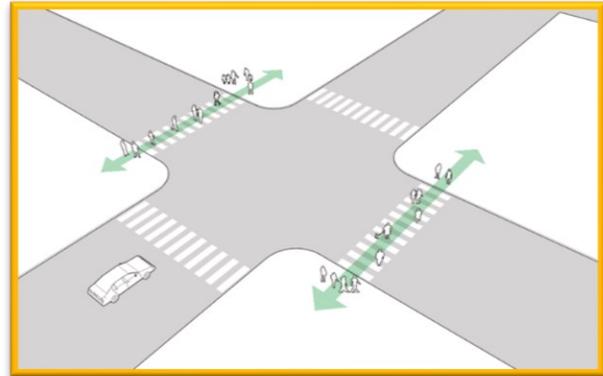
A Leading Pedestrian Interval (LPI) typically gives pedestrians a 3- to 7-second head start when entering an intersection before vehicles receive a green light in the same direction of travel. LPIs enhance the visibility of pedestrians within the crosswalk and reinforce that turning motorists must yield the right-of-way to pedestrians in the crosswalk. The City has numerous LPIs deployed at signalized intersections on VCU campuses, with plans to deploy additional LPIs throughout the City. It is recommended that LPIs be implemented at additional locations and incorporated into ongoing City of Richmond retiming efforts. Existing and recommended LPI locations are depicted in **Exhibit 3**.

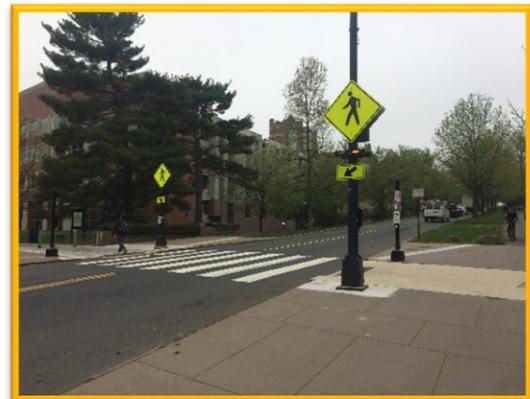
Rectangular Rapid Flashing Beacons (RRFBs) are pedestrian-activated flashing LED lights, typically mounted on existing crosswalk signage, that signal to drivers that a pedestrian is about to enter a crosswalk. RRFBs are placed on both sides of a crosswalk below the pedestrian crossing sign and above the arrow indication pointing at the crosswalk. RRFBs enhance the visibility of crosswalks and encourage motorists to yield to pedestrians crossing the street. Recommended RRFB locations are depicted in **Exhibit 3**.

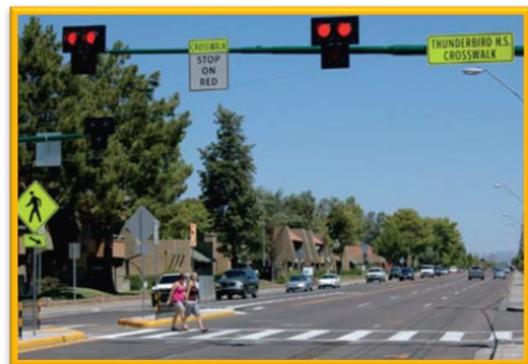
Pedestrian Hybrid Beacons (PHBs) are pedestrian-activated flashing LED lights that signal to drivers that a pedestrian is about to enter a crosswalk. Unlike RRFBs, PHBs are typically installed on multilane roadways and are mounted on mast arms above the crosswalk, much like a traffic signal. PHBs increase the safety of pedestrians crossing the street by providing them a signalized crossing that requires motorists to stop. A PHB is currently deployed on the Academic Medical Center Campus along Broad Street near 16<sup>th</sup> Street. Recommended PHB locations are depicted in **Exhibit 3**.

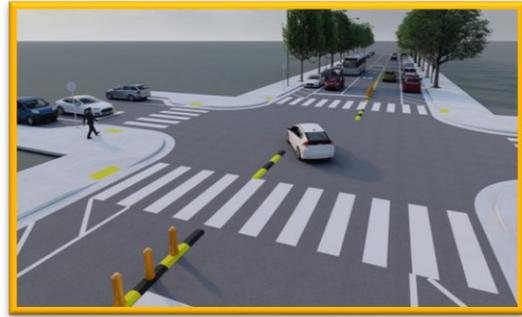
Left-turn hardening refers to the use of modular curbs, vertical delineators, and striping at intersections to reduce left-turning speeds and to prevent “corner cutting.” Left-turn hardening emphasizes the separation between travel directions, guides vehicles into the receiving lane, and reduces turning speeds, reducing the conflict zone between turning vehicles and people biking and walking. Left-turn hardening is recommended at the southbound approach of the intersection of Marshall Street and 13<sup>th</sup> Street, see **Exhibit 3**.

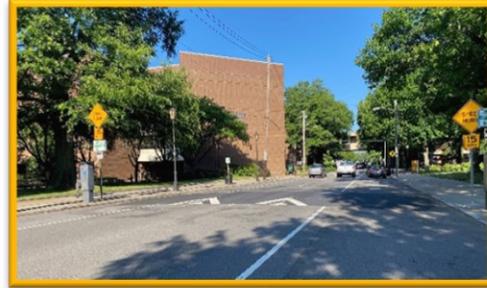
Speed tables are elongated speed humps with a flat top. Speed tables are typically long enough for an entire wheelbase of a passenger car to rest on top. Speed tables physically encourage drivers to slow down. The City of Richmond installed 13 new speed tables within the VCU Monroe Park Campus in May 2023. Locations depicted in **Exhibit 4** include existing speed tables and locations where speed tables are recommended for evaluation; locations for speed tables are subject to the review and approval of various City emergency service units.

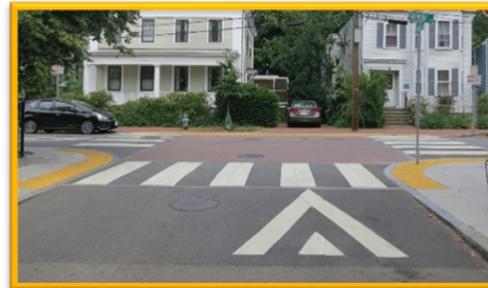
Raised intersections are raised plateaus that extend through the length and width of an intersection. Inclines are provided on intersection approaches to ramp up onto the raised portion of the intersection. Pedestrian crosswalks are also elevated as part of this treatment. Raised intersections physically encourage motorists to reduce their speeds approaching the intersection and enhance the visibility the crosswalks. Raised intersections are currently deployed on the Monroe Park Campus at the intersections of Floyd Avenue at Linden Street and Grove Avenue at Linden Street. An additional raised intersection is recommended for evaluation at the intersection of Clay Street and 10<sup>th</sup> Street as part of future development (see **Exhibit 4**).

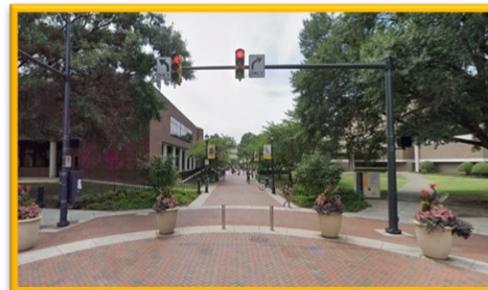
Road closures are accomplished by installing a physical barrier that blocks a street to motor vehicle traffic. Road closures should allow for the free movement of all pedestrians and cyclists. Road closures are currently deployed on the VCU Monroe Park Campus along Linden Street between Floyd Avenue and Cary Street, along Shafer Street between Franklin Street and Park Avenue, and along Park Avenue between Linden Street and Cathedral Place. The cost of implementing road closures varies and is dependent on the complexity of streetscape elements and physical barriers installed. It is suggested that the roads marked in orange in **Exhibit 4** be evaluated for potential road closures. This will require additional study and engagement with impacted property owners and emergency services agencies. This study should evaluate the impact of the closure of the roads marked in orange to motor vehicle traffic, bicyclists, and pedestrians within and around the Monroe Park Campus.

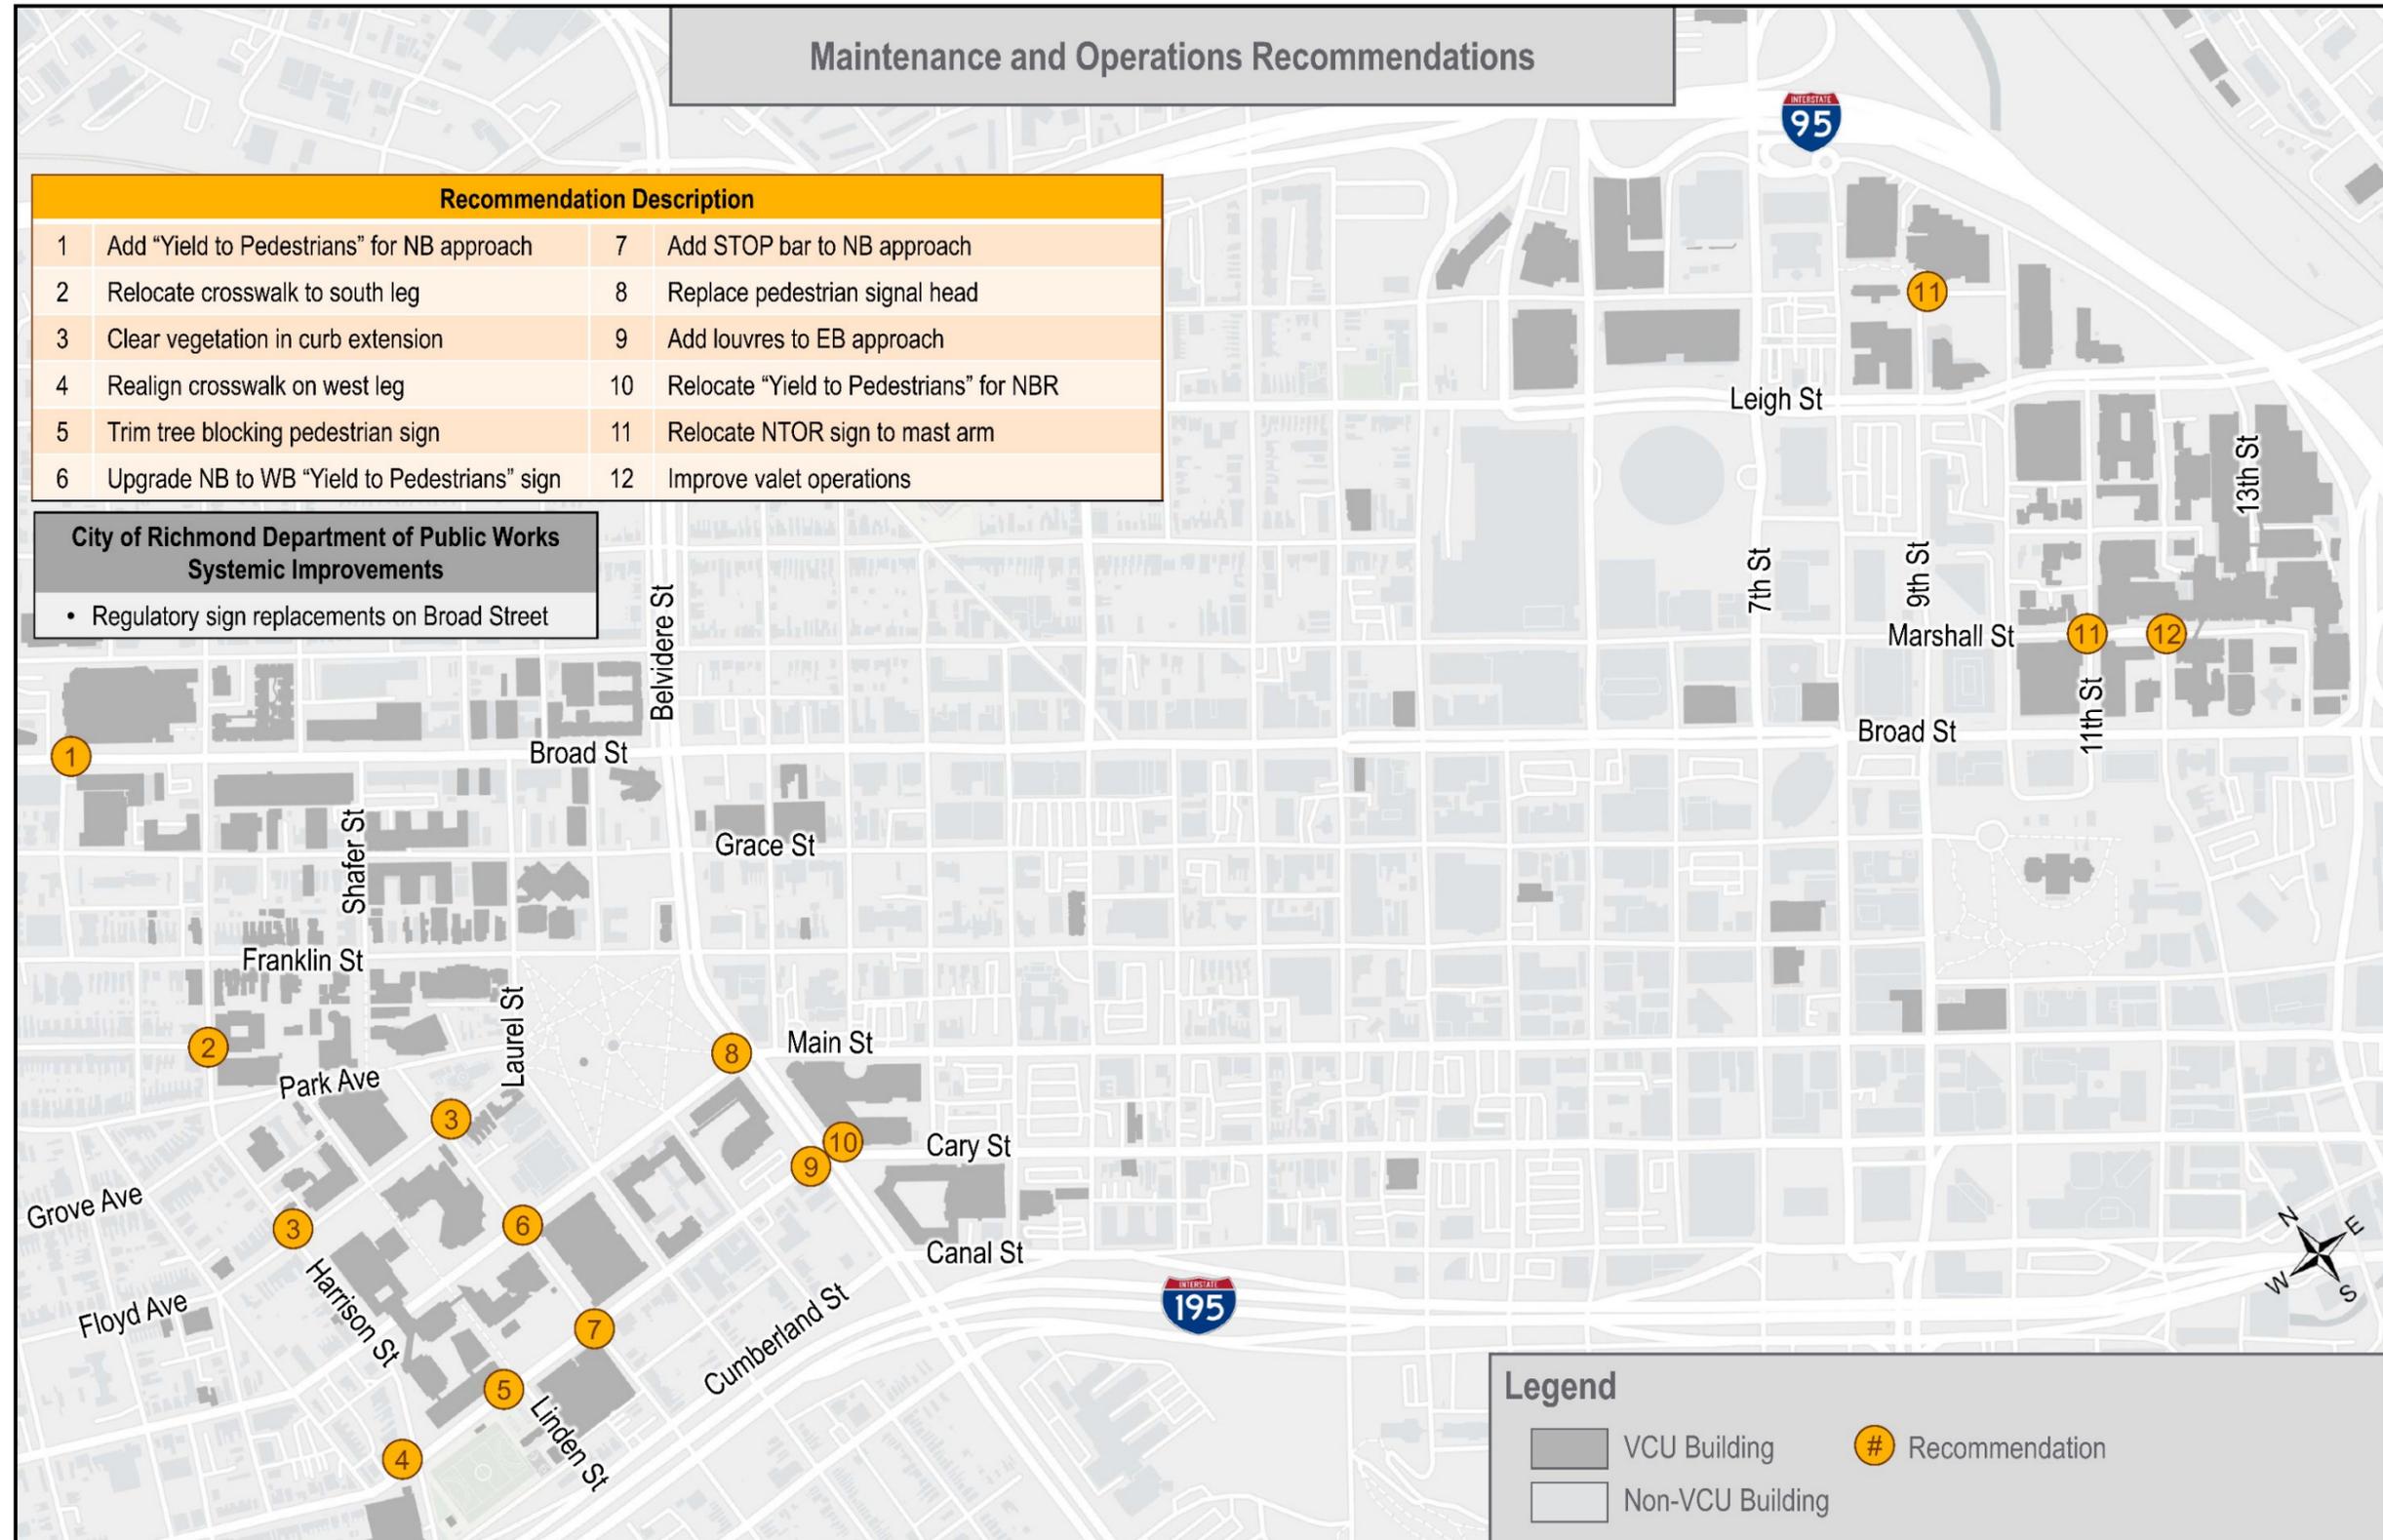
**Exhibit 5: Maintenance and Operations Recommendations**

Based on the conducted field observations, several maintenance and operations recommendations were identified. The recommendations include vegetation trimming, sign upgrades, pavement marking and stop bar restoration, minor signal modifications, and a recommendation to review and improve valet operations. The maintenance and operations recommendations are depicted in **Exhibit 5**.

Signal louvers are devices mounted inside of a traffic signal to limit the distance from the intersection where signal indications are visible. Signal louvers are recommended on the eastbound approach of Cary Street at Belvidere Street to limit the distance that the green traffic signal ball is visible until after drivers pass the existing crosswalk at Pine Street. The louvers are intended to keep drivers focused on looking for pedestrians in the crosswalk at Pine Street before turning their attention to the signal at Belvidere Street.

- The City has completed the identified sign maintenance recommendations identified in this report.
- The City and VCU will revisit improvements to the valet area on Marshall Street.
- The City has installed signal louvers on the eastbound approach of the intersection of Cary Street and Belvidere Street.
- The City is in the process of replacing regulatory signs on Broad Street.

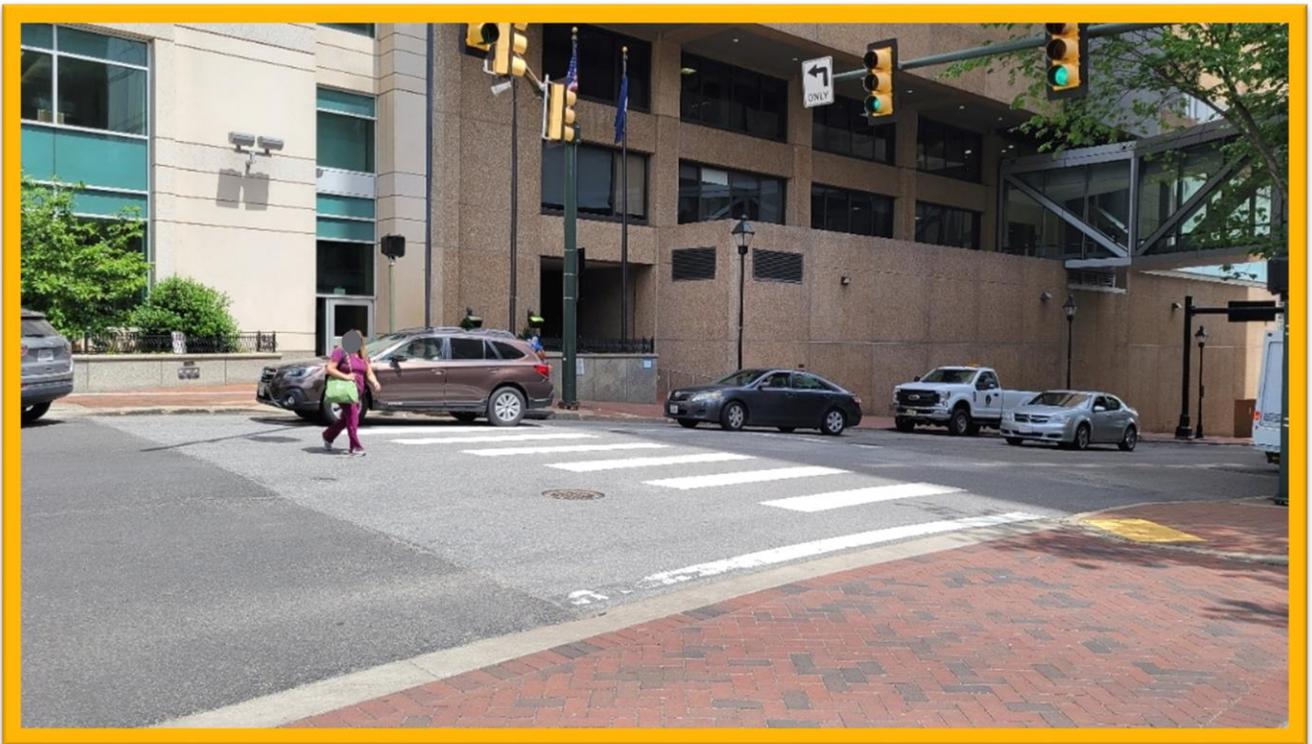
**Figure A-1: Valet Queues Blocking Crosswalk and Pedestrian Crossing at Marshall Street and 12<sup>th</sup> Street**

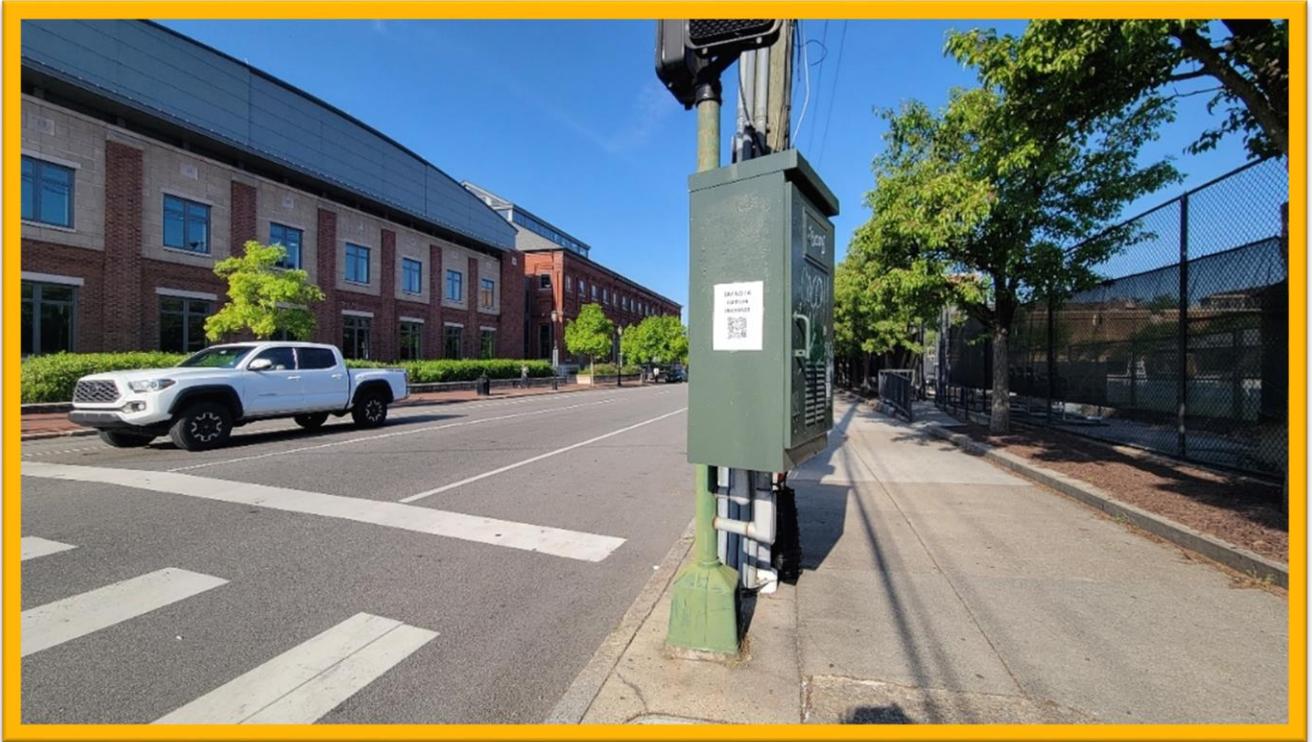
The five grey icons show where other objects impair visibility, such as the traffic signal cabinet at Cary Street and Cherry Street, as shown in **Figure A-2**, and the traffic signal poles at Cary Street and Harrison Street.

Figure A-2: Impaired Pedestrian Sight Distance at Cary Street and Cherry Street

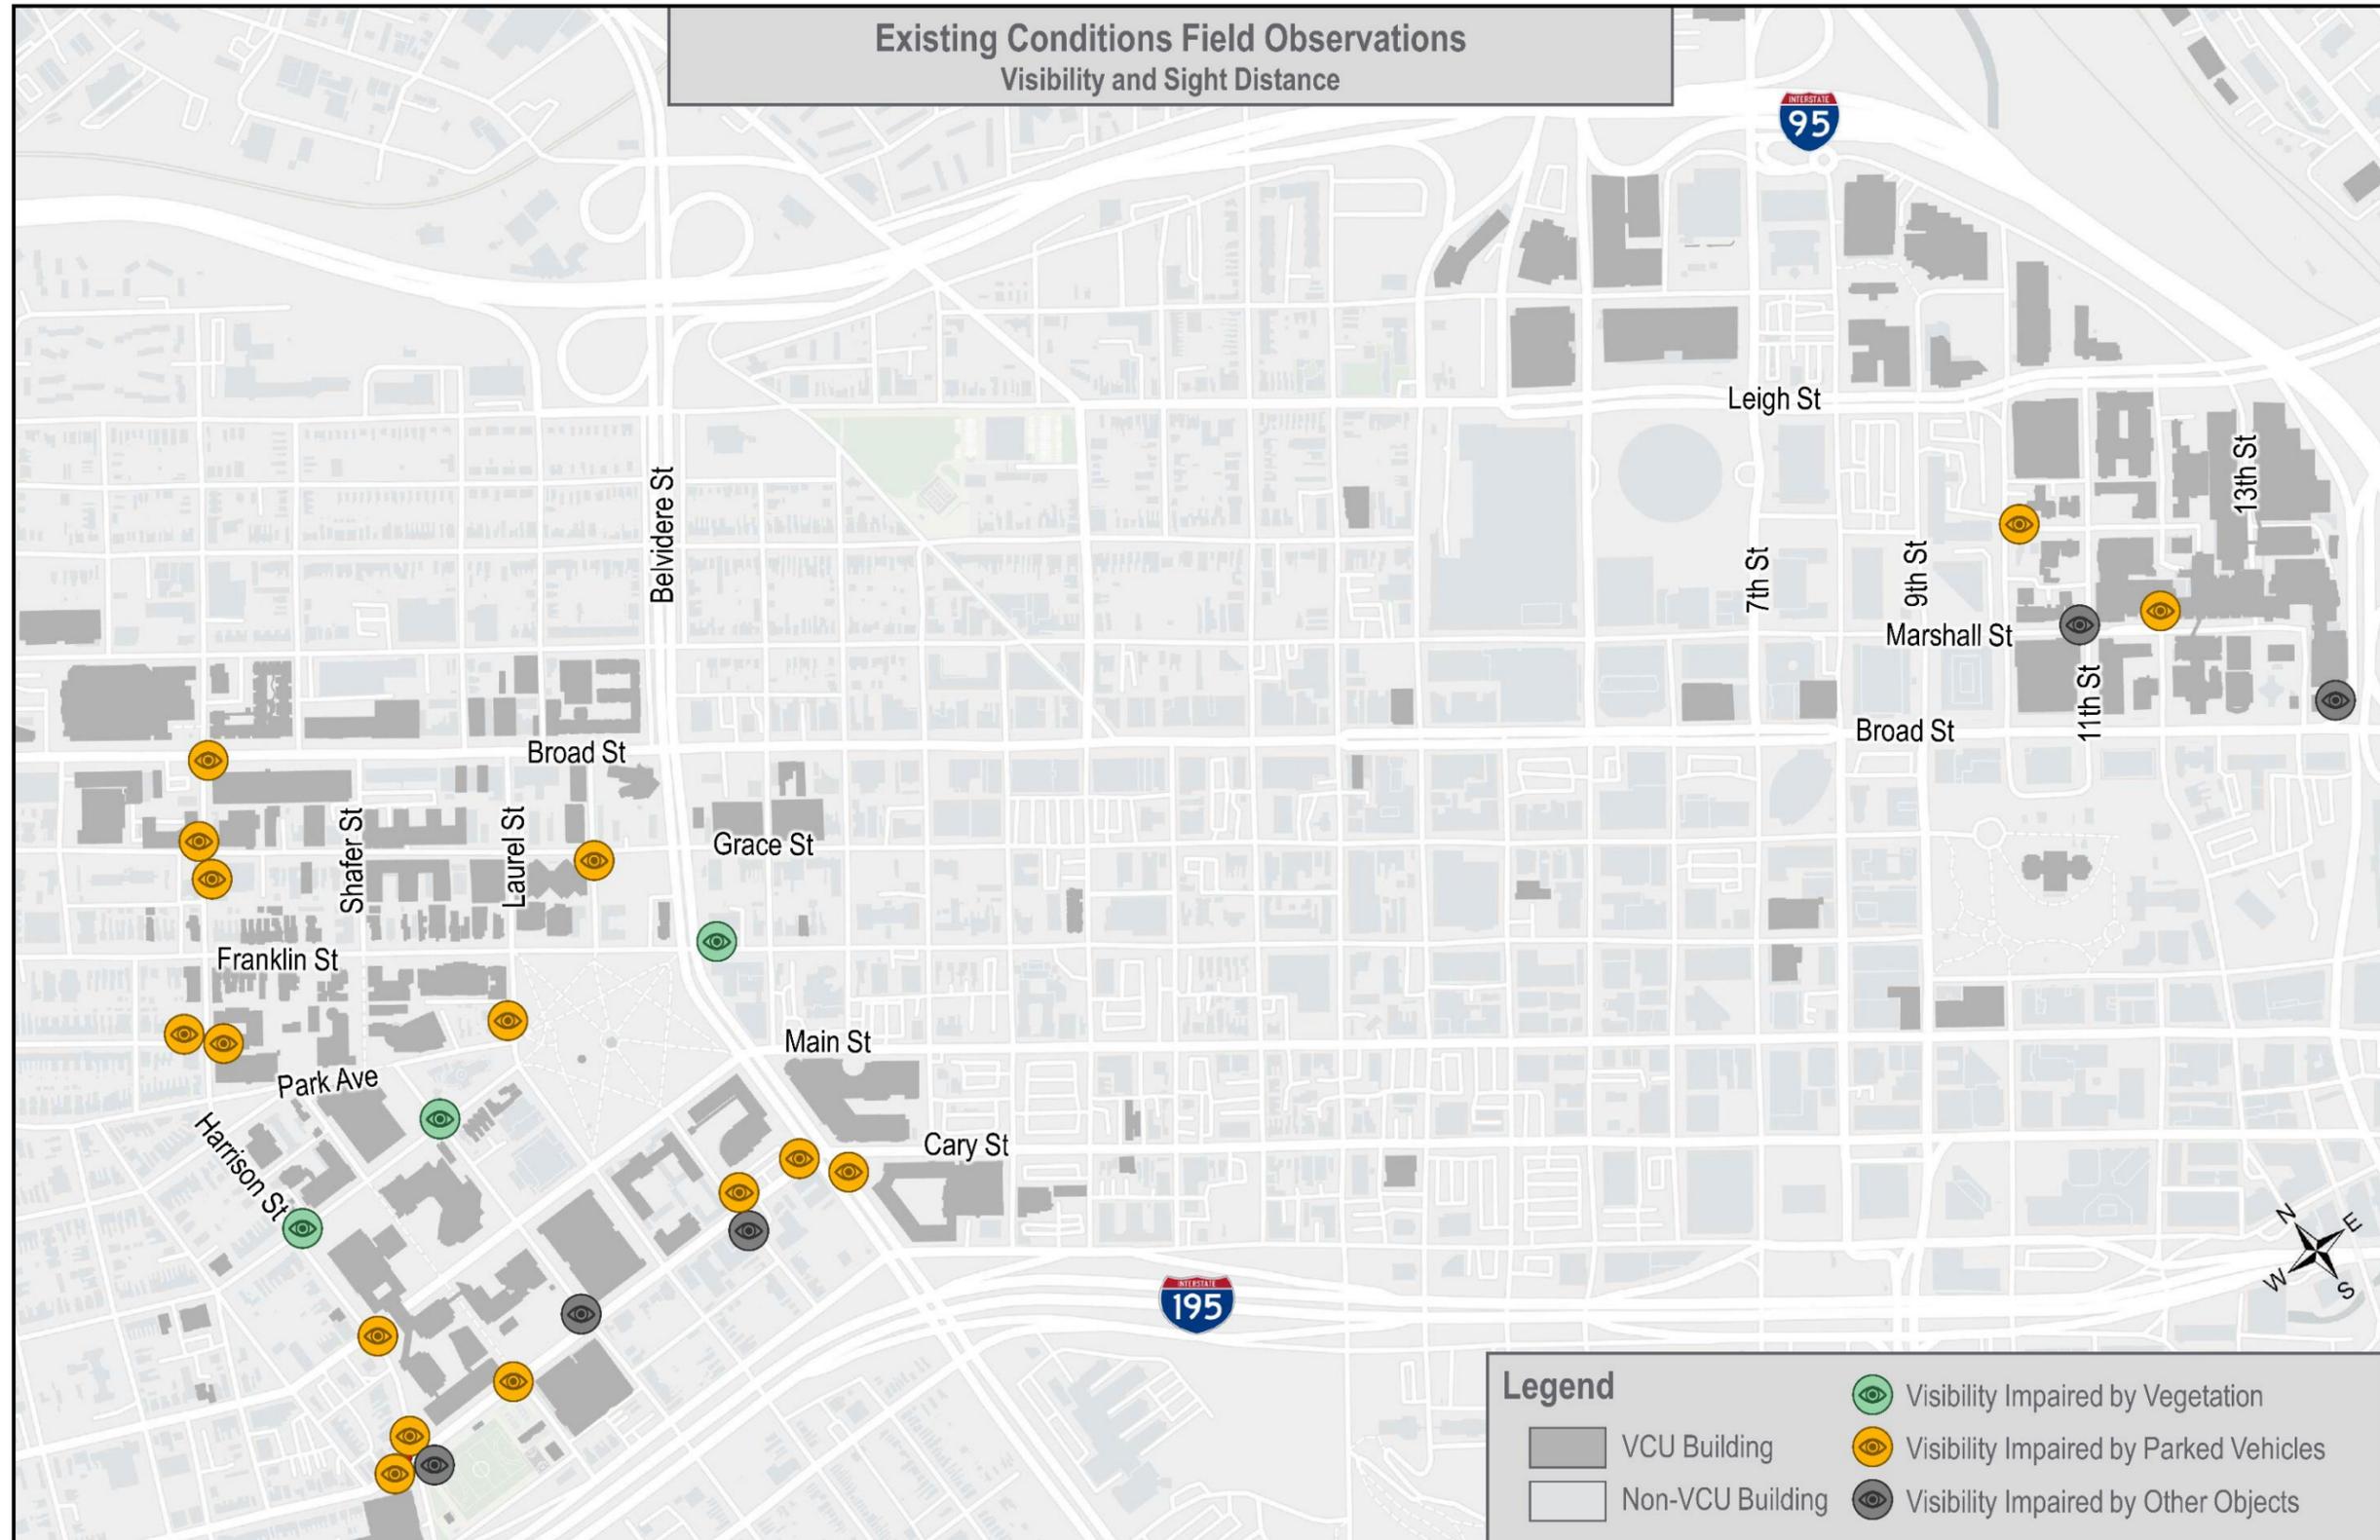
Exhibit A-2: Visibility and Sight Distance Observations

It is crucial that all road users (including pedestrians, cyclists, and motorists) can fully see their surroundings and anticipate potential conflict at locations where pedestrians, cyclists, and vehicles interact. The study team identified 24 locations on the VCU Monroe Park and Academic Medical Center Campuses where vegetation, parked vehicles, or traffic signal infrastructure impaired visibility, as shown in **Exhibit A-2**.

The three green icons show locations where the study team observed vegetation in landscaped bump-outs or a nearby tree impairing pedestrian or cyclist / motorist visibility.

The 16 yellow icons show locations where the study team observed a vehicle parked in a way that impedes the view of oncoming traffic or blocks a crosswalk. At these locations, relocating or removing on-street parking, loading areas, or bus stops may improve sight distance and overall safety for pedestrians. **Figure A-1** shows a unique situation the study team observed on the Academic Medical Center Campus where vehicles waiting for valet parking were stopped in the crosswalk. The pedestrian was also crossing against an opposing green light.

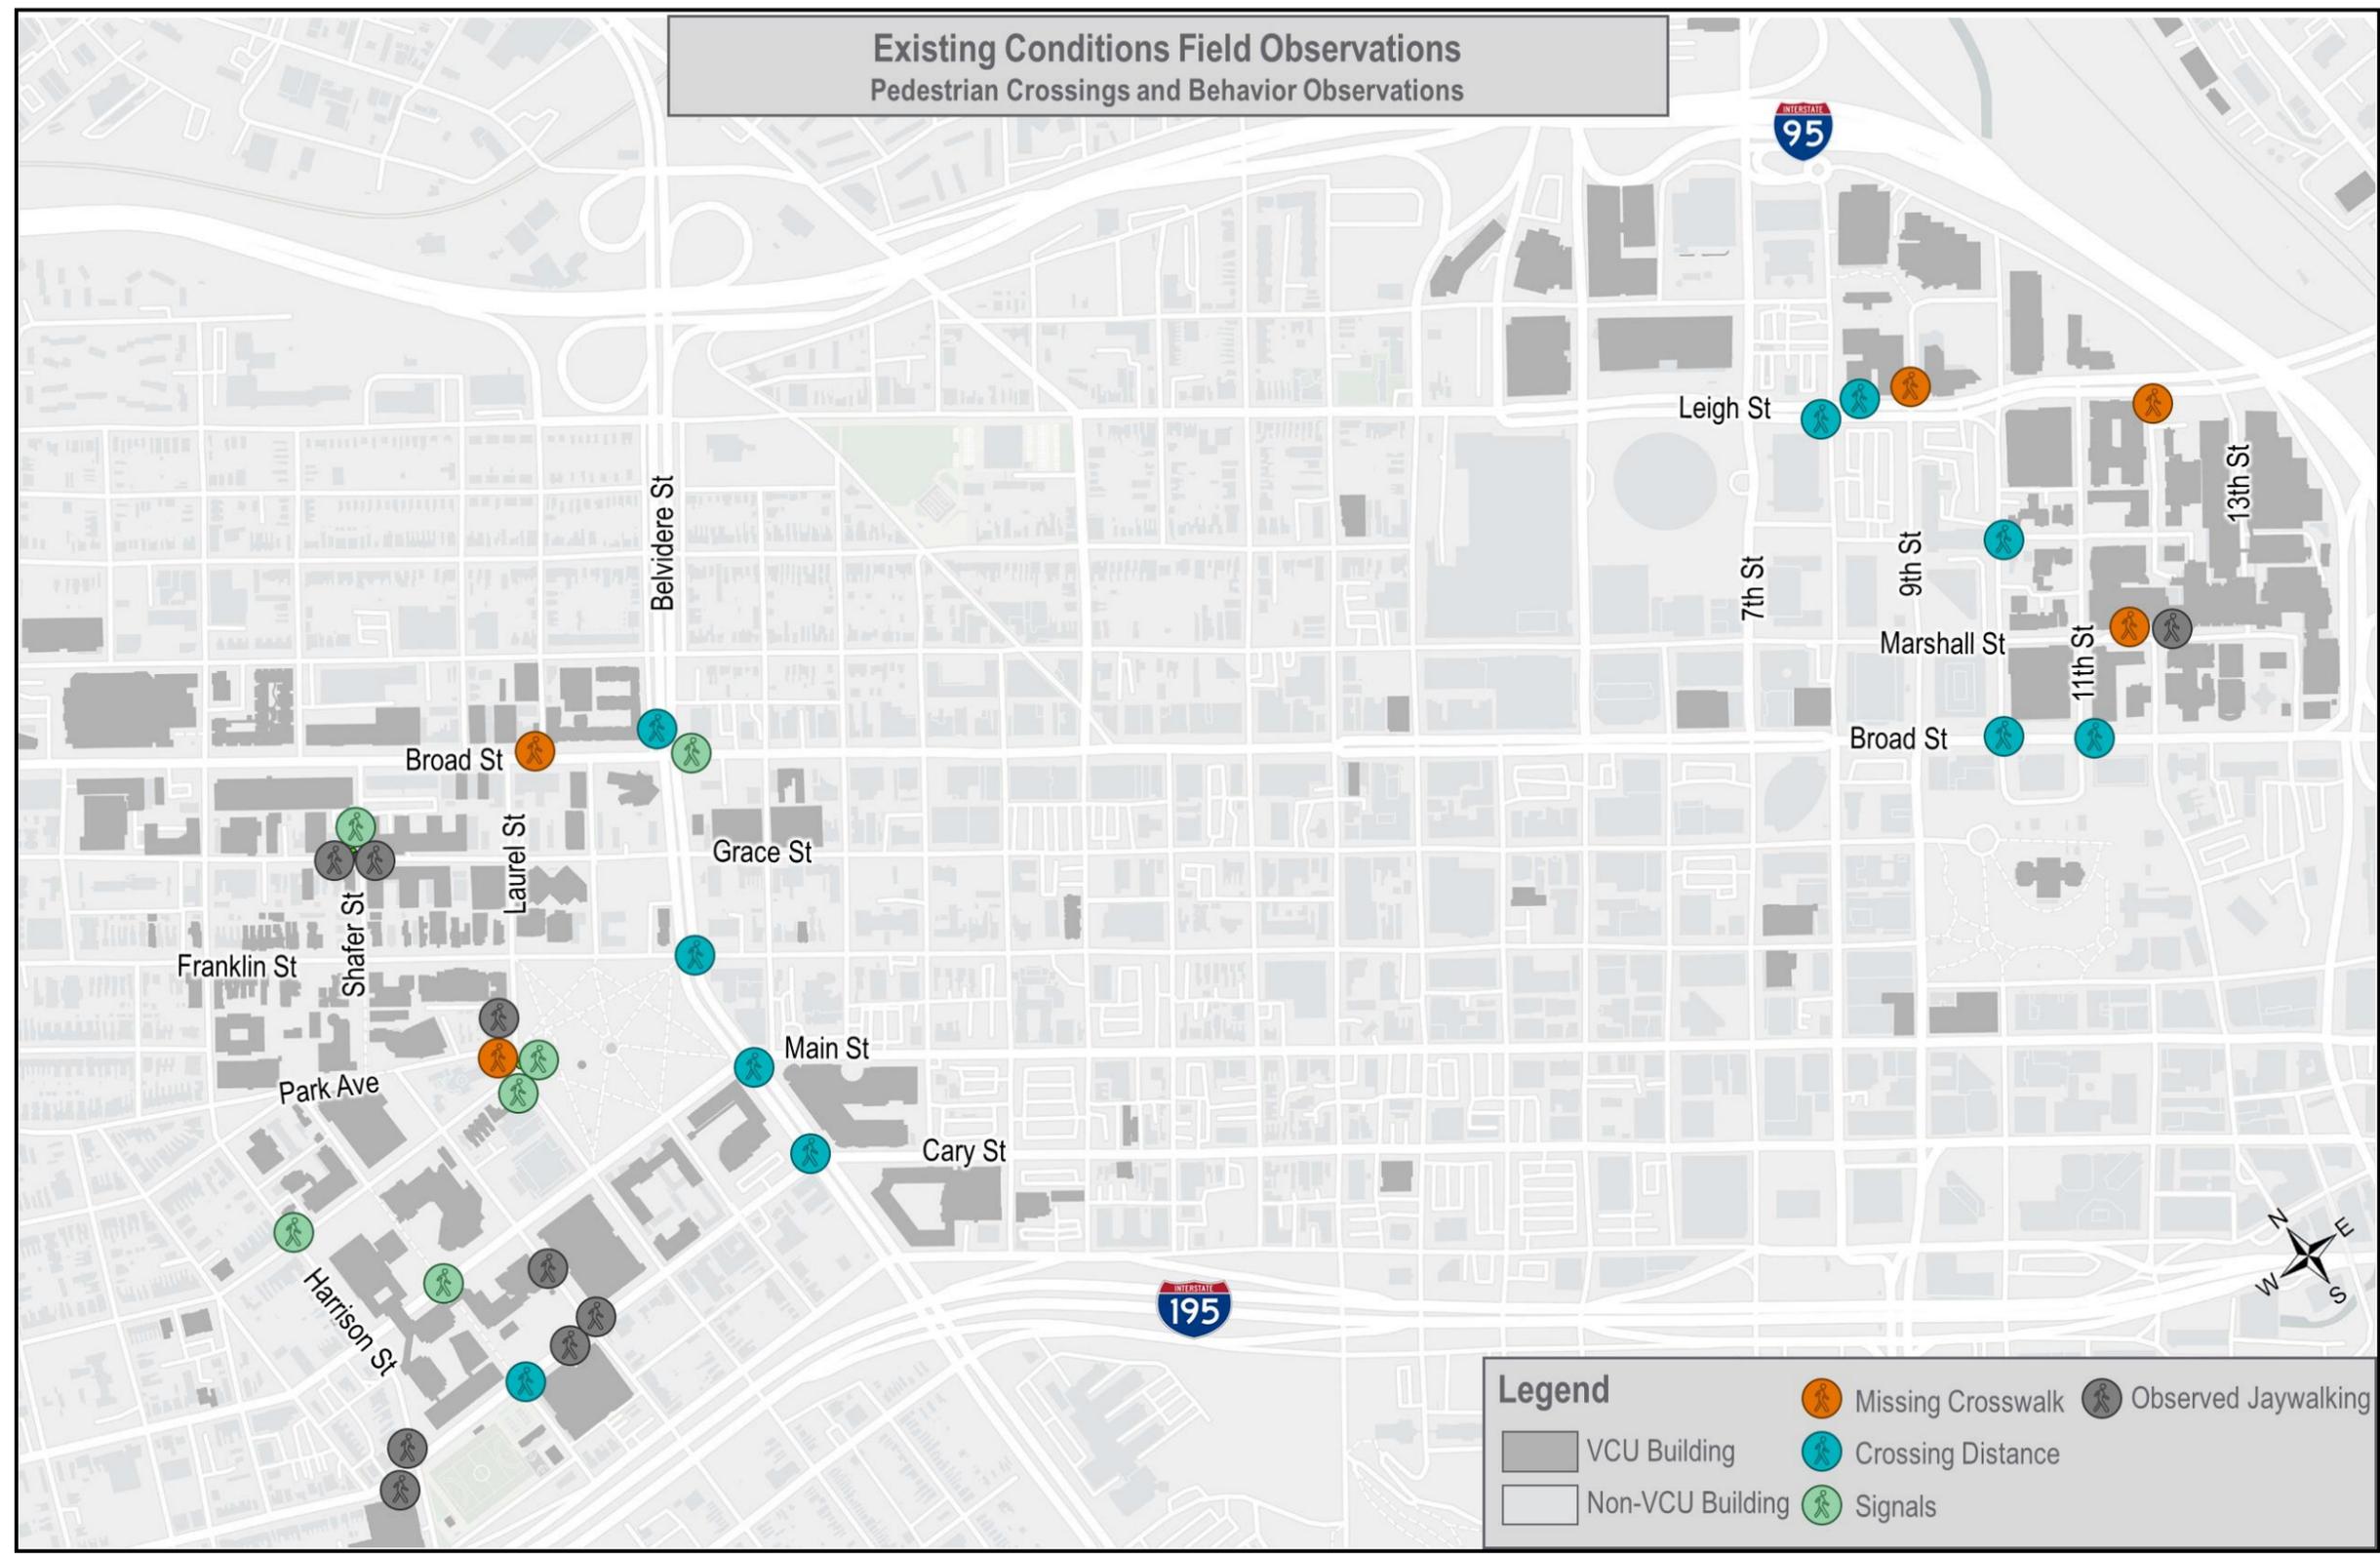
Exhibit A-3: Pedestrian Crossings and Behavior Observations

Crossing a heavily trafficked street is a necessary but potentially dangerous activity for pedestrians. It is essential that crossings are designed with pedestrians in mind and are marked clearly, have signal timings favoring pedestrians, and offer full visibility for motorists and pedestrians. Crossings should be designed with an understanding that humans make mistakes and unsafe decisions—as both motorists and pedestrians. **Exhibit A-3** presents 31 locations within the Monroe Park and Academic Medical Center Campuses where crossing infrastructure can improve. The Exhibit also present locations where the study team observed pedestrian demonstrating potentially unsafe crossing behavior.

The four locations shown in orange may benefit from the addition of a crosswalk as there was observed pedestrian activity but no crosswalk.

The eight locations shown in green denote locations where the study team observed traffic signals that lack pedestrian signal infrastructure or could have signal timings improved to better serve pedestrian volumes.

The nine locations shown in grey depict locations where the study team observed pedestrians crossing at a potentially unsafe location or during the Do Not Walk signal phase. The study team observed some pedestrians acting like they were in a herd—following other pedestrians and crossing against a Do Not Walk signal without checking for oncoming vehicles—at several locations. The study team will further investigate these locations to identify improvements to better direct pedestrians and vehicles at intersections and provide safe and convenient crossing opportunities.
