**VCU**

**September 2023**

# Pedestrian Safety Study

## Potential Improvements and Recommendations

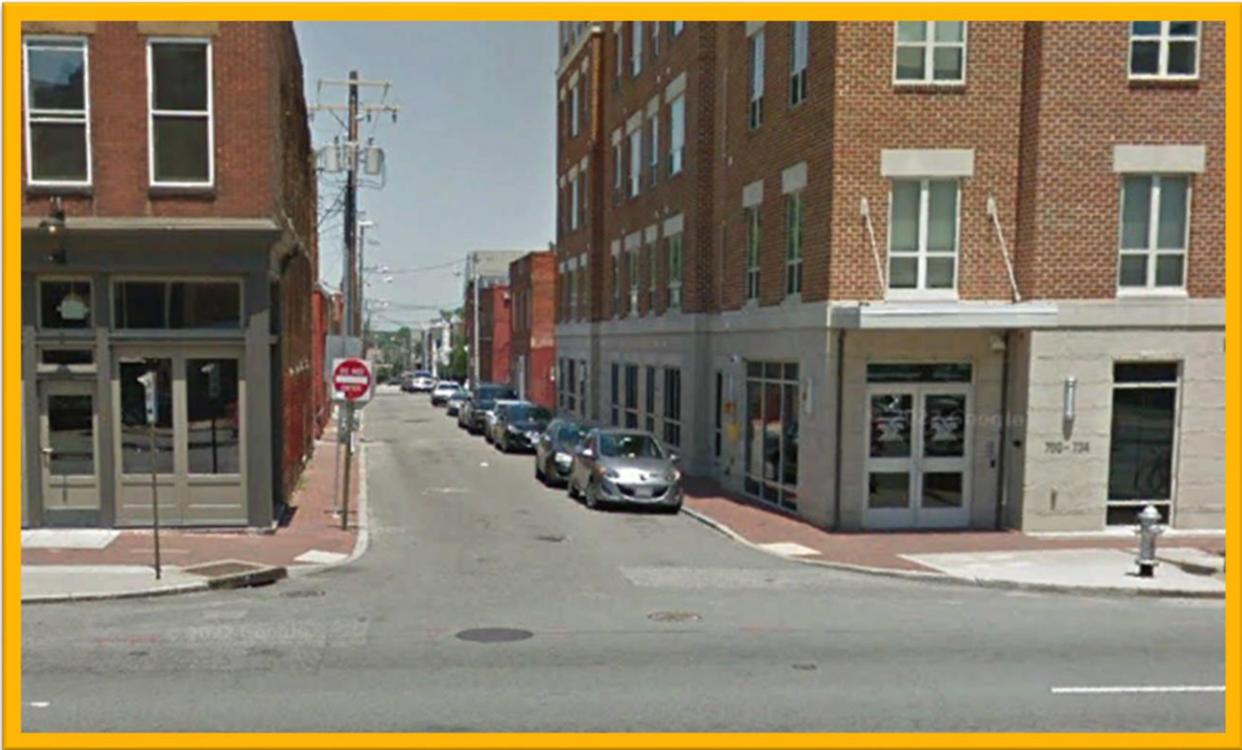
The seven orange locations represent locations with inadequate road markings. Road marking concerns range from missing stop bars to confusing road markings. Confusing road markings include locations where the study team observed motorists using a bus lane or parking lane as a right-turn lane. Signage and pavement markings that offer conflicting information can be dangerous for pedestrians and motorists. **Figure A-3** shows an intersection where there are no stop bar or crosswalk markings.

**Figure A-3: Missing Stop Bar and Crosswalk at Broad Street and Gilmer Street**

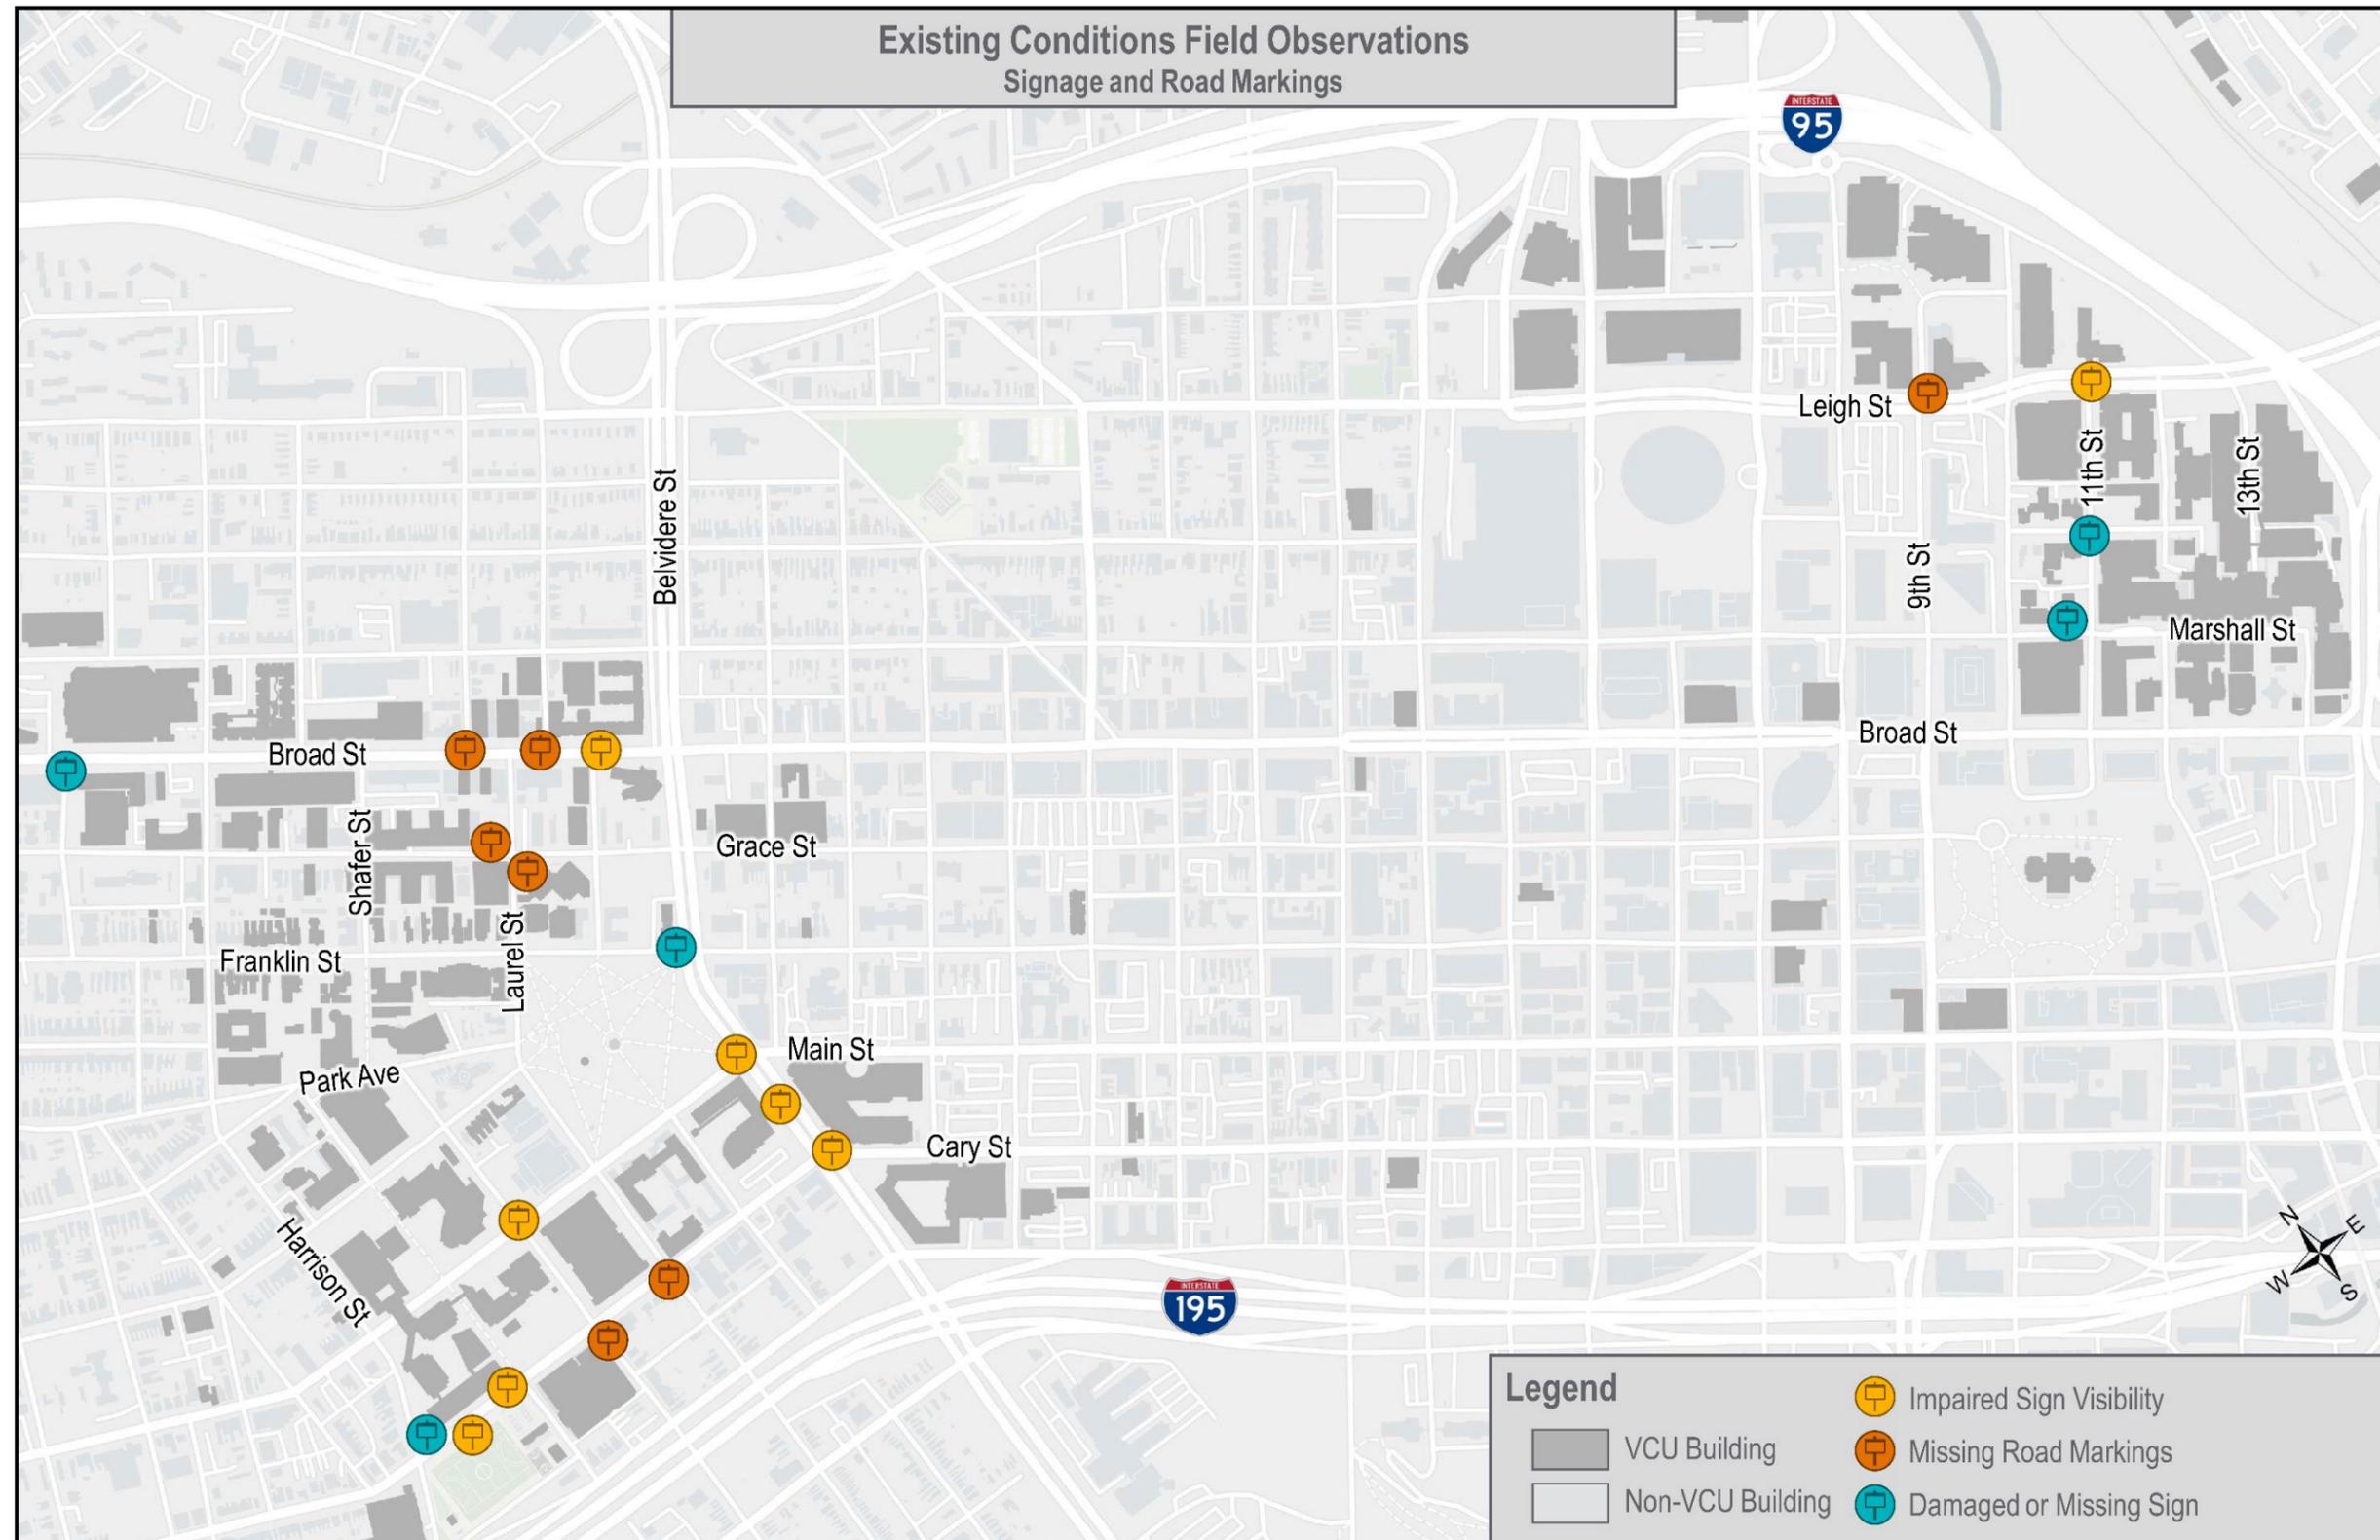
**Exhibit A-4: Signage and Road Marking Observations**

Proper signage and pavement markings direct traffic and depicts rules of the road and road configurations to promote safety for all road users. **Exhibit A-4** includes 20 opportunities to enhance existing signs and markings.

The five blue locations represent signs that require maintenance or are installed in an improper location. These locations include graffitied signs, inconsistent sign placement, and unmarked locations with high pedestrian activity. One such location is the intersection of Clay Street and 11<sup>th</sup> Street, where high pedestrian volumes conflict with free-flowing traffic.

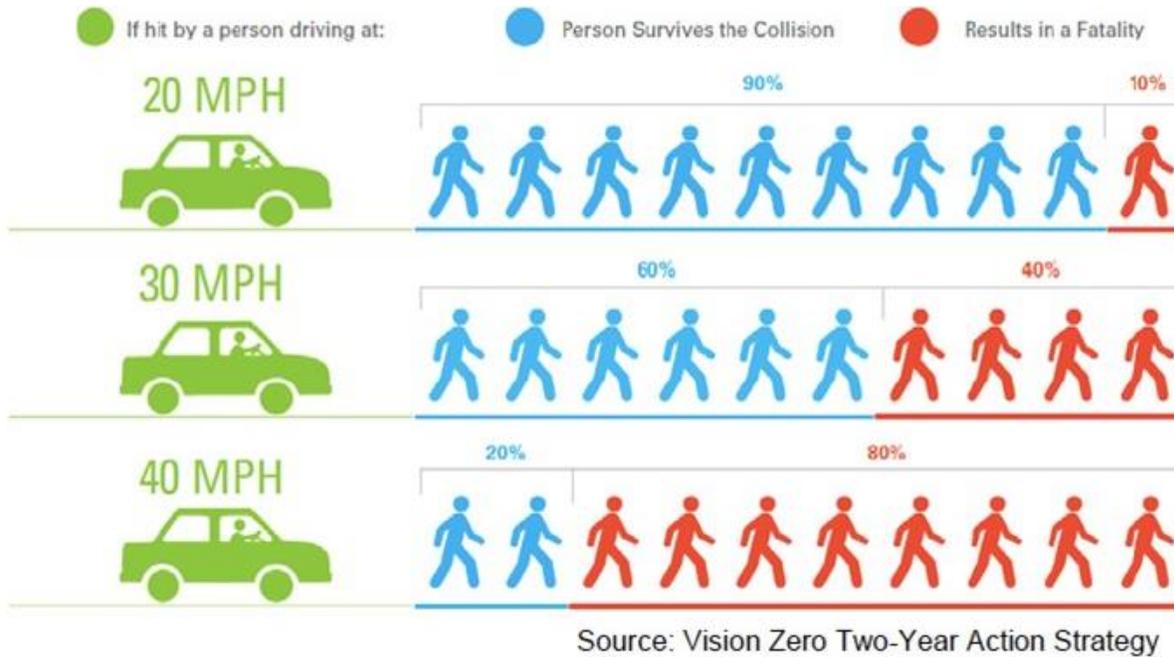
**Figure A-4: Pedestrian Fatality Probability based on Vehicle Speed**

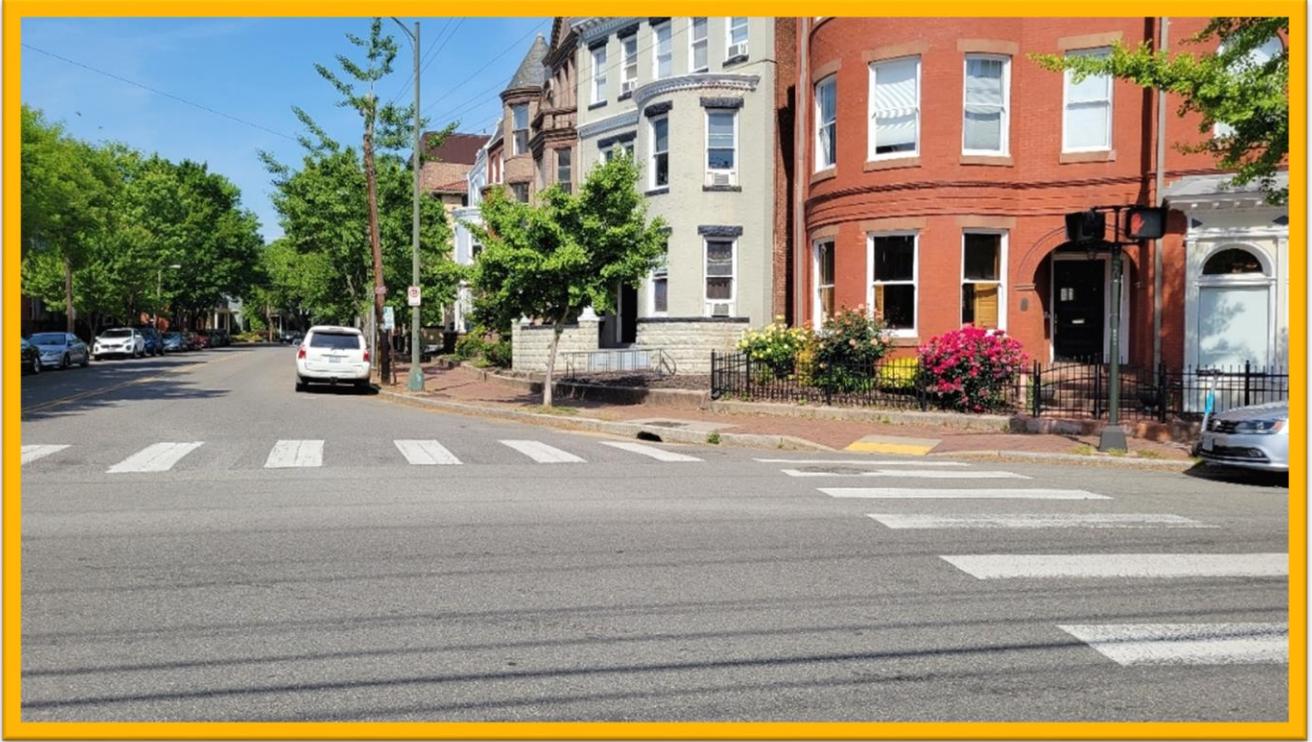
The seven yellow icons depict locations where the study team observed motorists turning at high speeds. Taking a turn with too sharp an angle or at too high a speed increases the likelihood and potential severity of a vehicle-pedestrian collision. Motorists taking a turn too quickly can lose control of the vehicle, drive over the curb, not notice a pedestrian, or not have enough time to brake. This category of observations also includes intersections with a large turning radius as the radius enables motorists to turn quickly through the intersection and increases the crossing distance for pedestrians. **Figure A-5** presents an example of a corner with a large radius that enables motorists to take right turns at a higher speed.

**Figure A-5: Large Curb Radius at Intersection of Harrison Street and Grove Avenue**

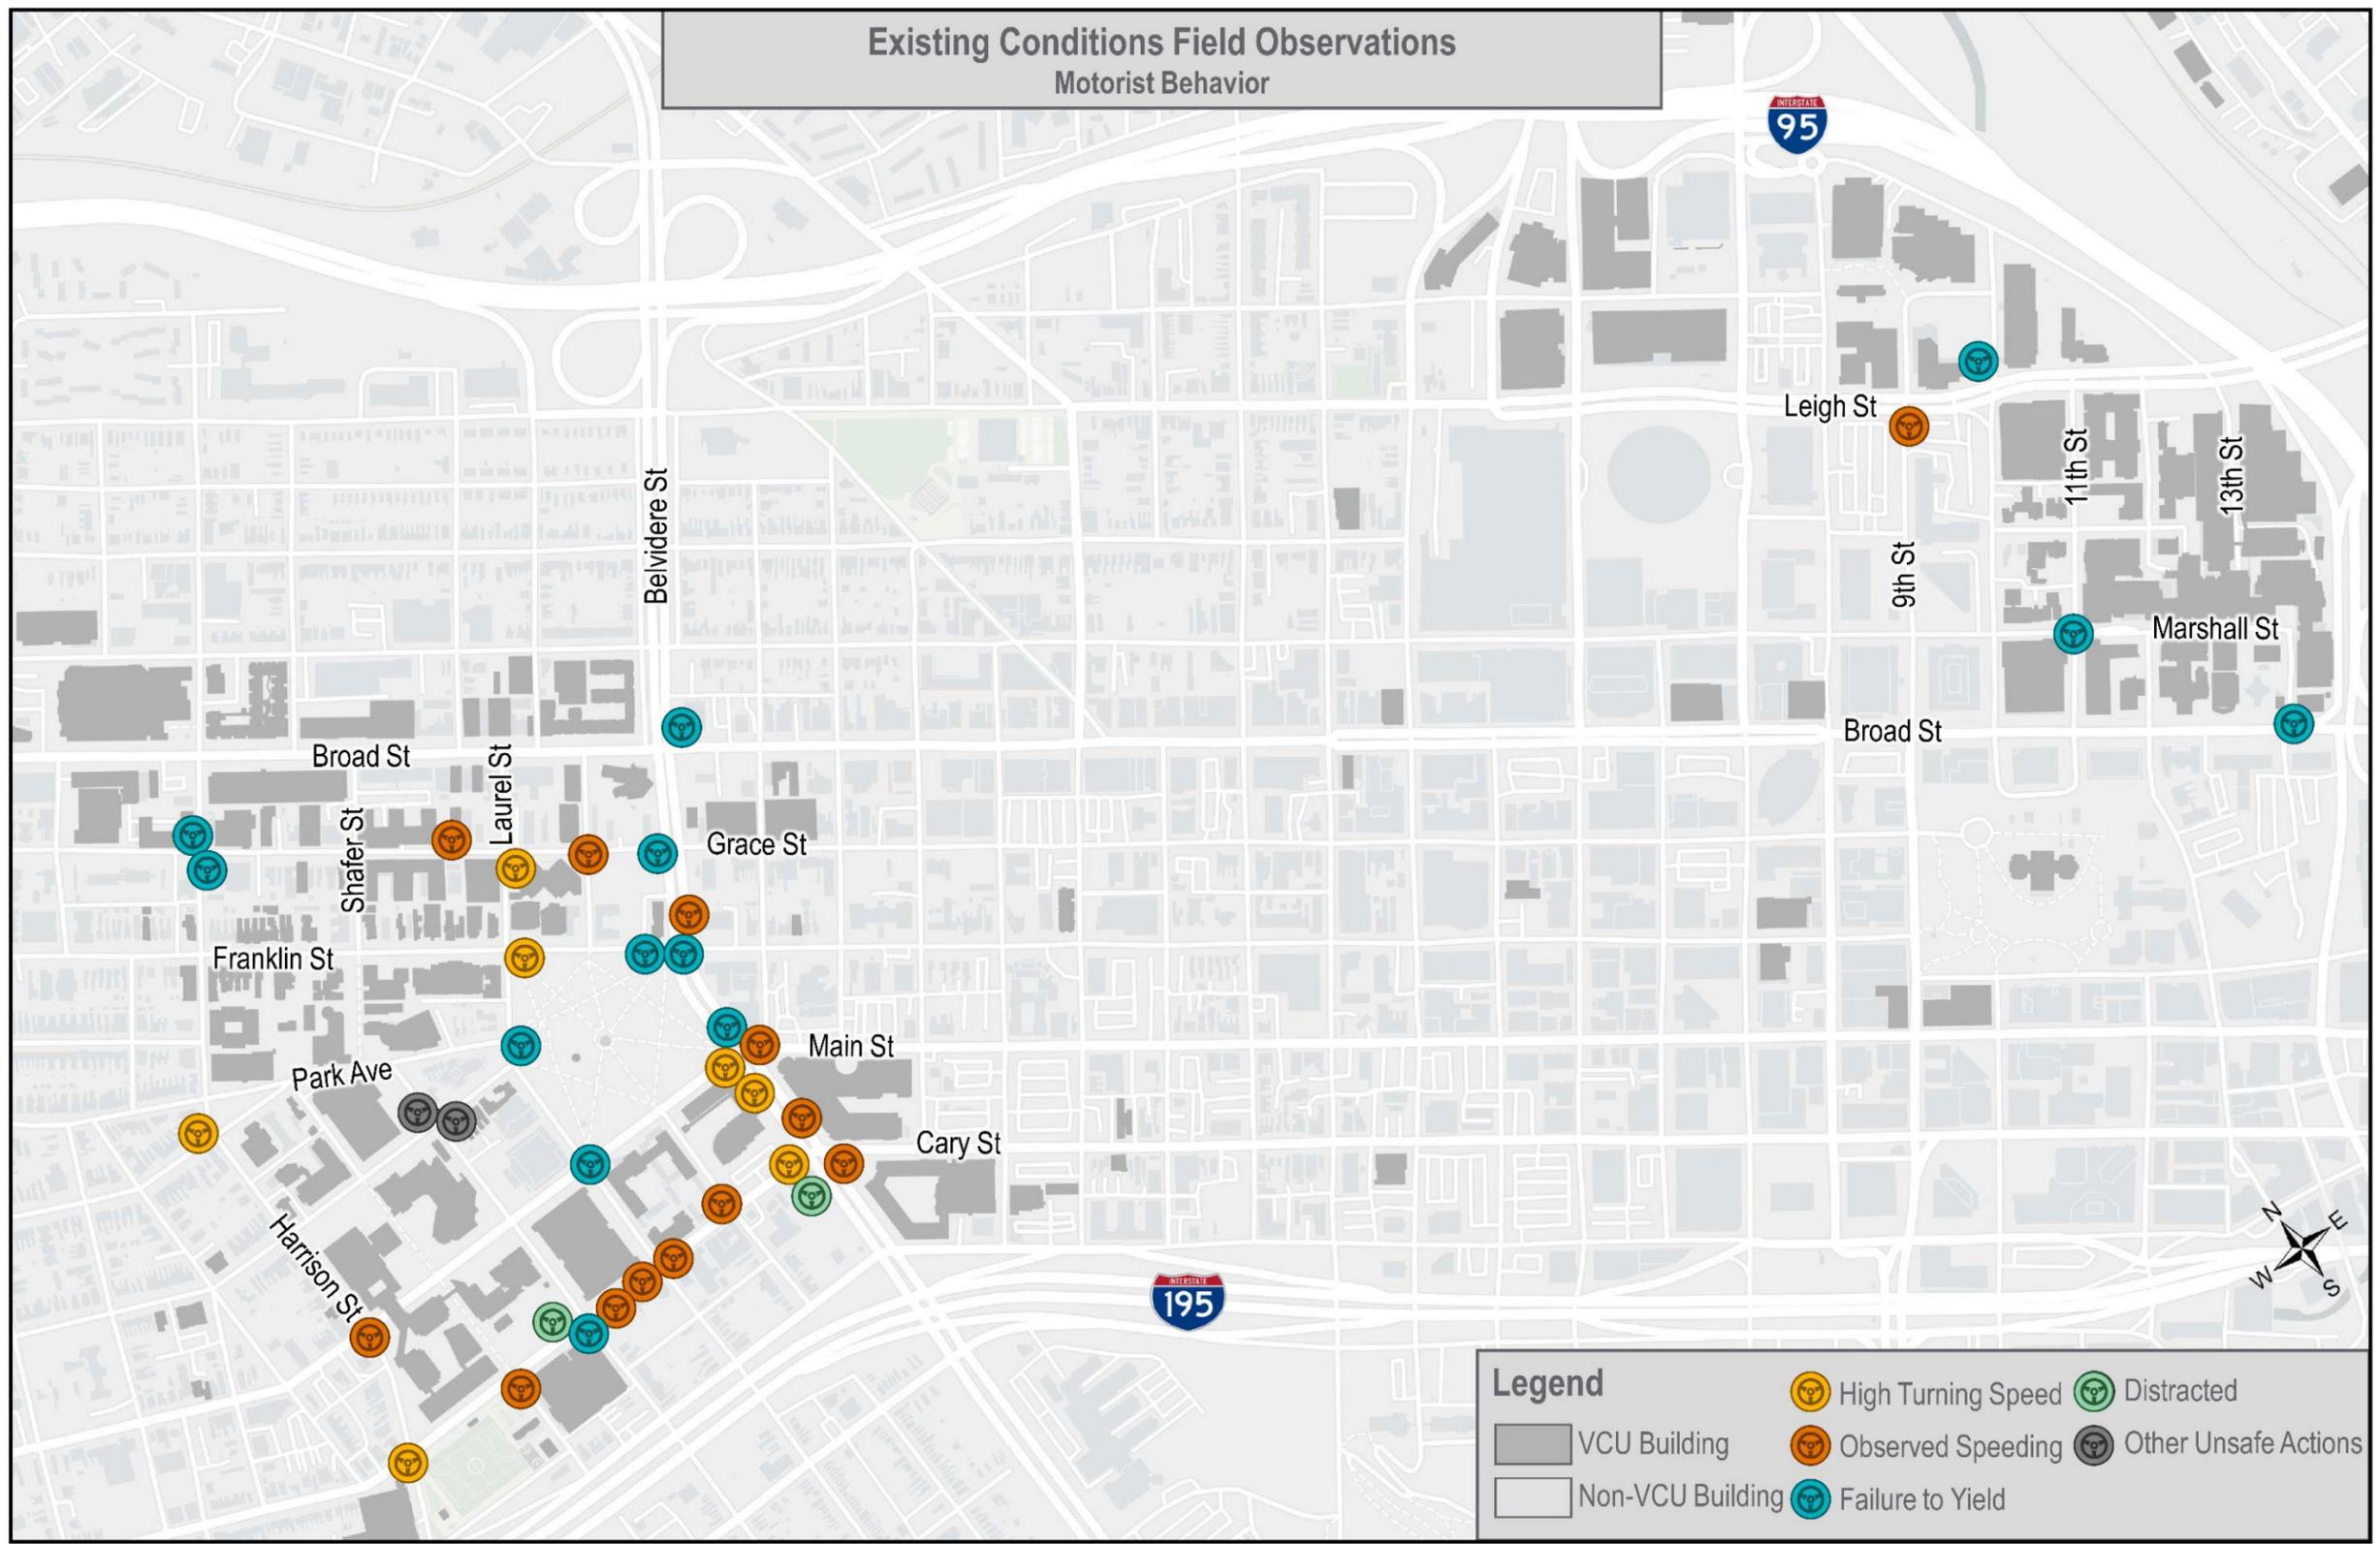
Exhibit A-5: Motorist Behavior Observations

While motorists are responsible for their own behavior and following traffic laws such as yielding to pedestrians and maintaining safe speeds, there are infrastructure elements that can encourage better situational awareness and traffic calming. Speeding vehicles create significant danger for pedestrians and increase severity of any conflict. **Figure A-4** demonstrates how increased vehicular speeds dramatically increase the likelihood of pedestrian fatality in the event of a collision. **Exhibit A-5** presents 37 locations where the study team observed unsafe motorist behavior.

The thirteen red icons depict locations where the study team observed vehicles exceeding the posted speed limit.

The thirteen blue icons depict locations where the study team observed motorists failing to yield to pedestrians. In some cases, this failure to yield occurred because motorists advanced into the crosswalk to make a right turn at a red light, which blocked crossing pedestrians. In other instances, when turning motorists had a green light and pedestrians had a walk signal simultaneously, motorists ignored the pedestrian right-of-way and turned before pedestrians had

a chance to start crossing. At the two locations in green, the study team observed distracted motorists.

The two locations in grey depict where the study team noticed motorists making other kinds of unsafe maneuvers, such as unsafe U-turns.

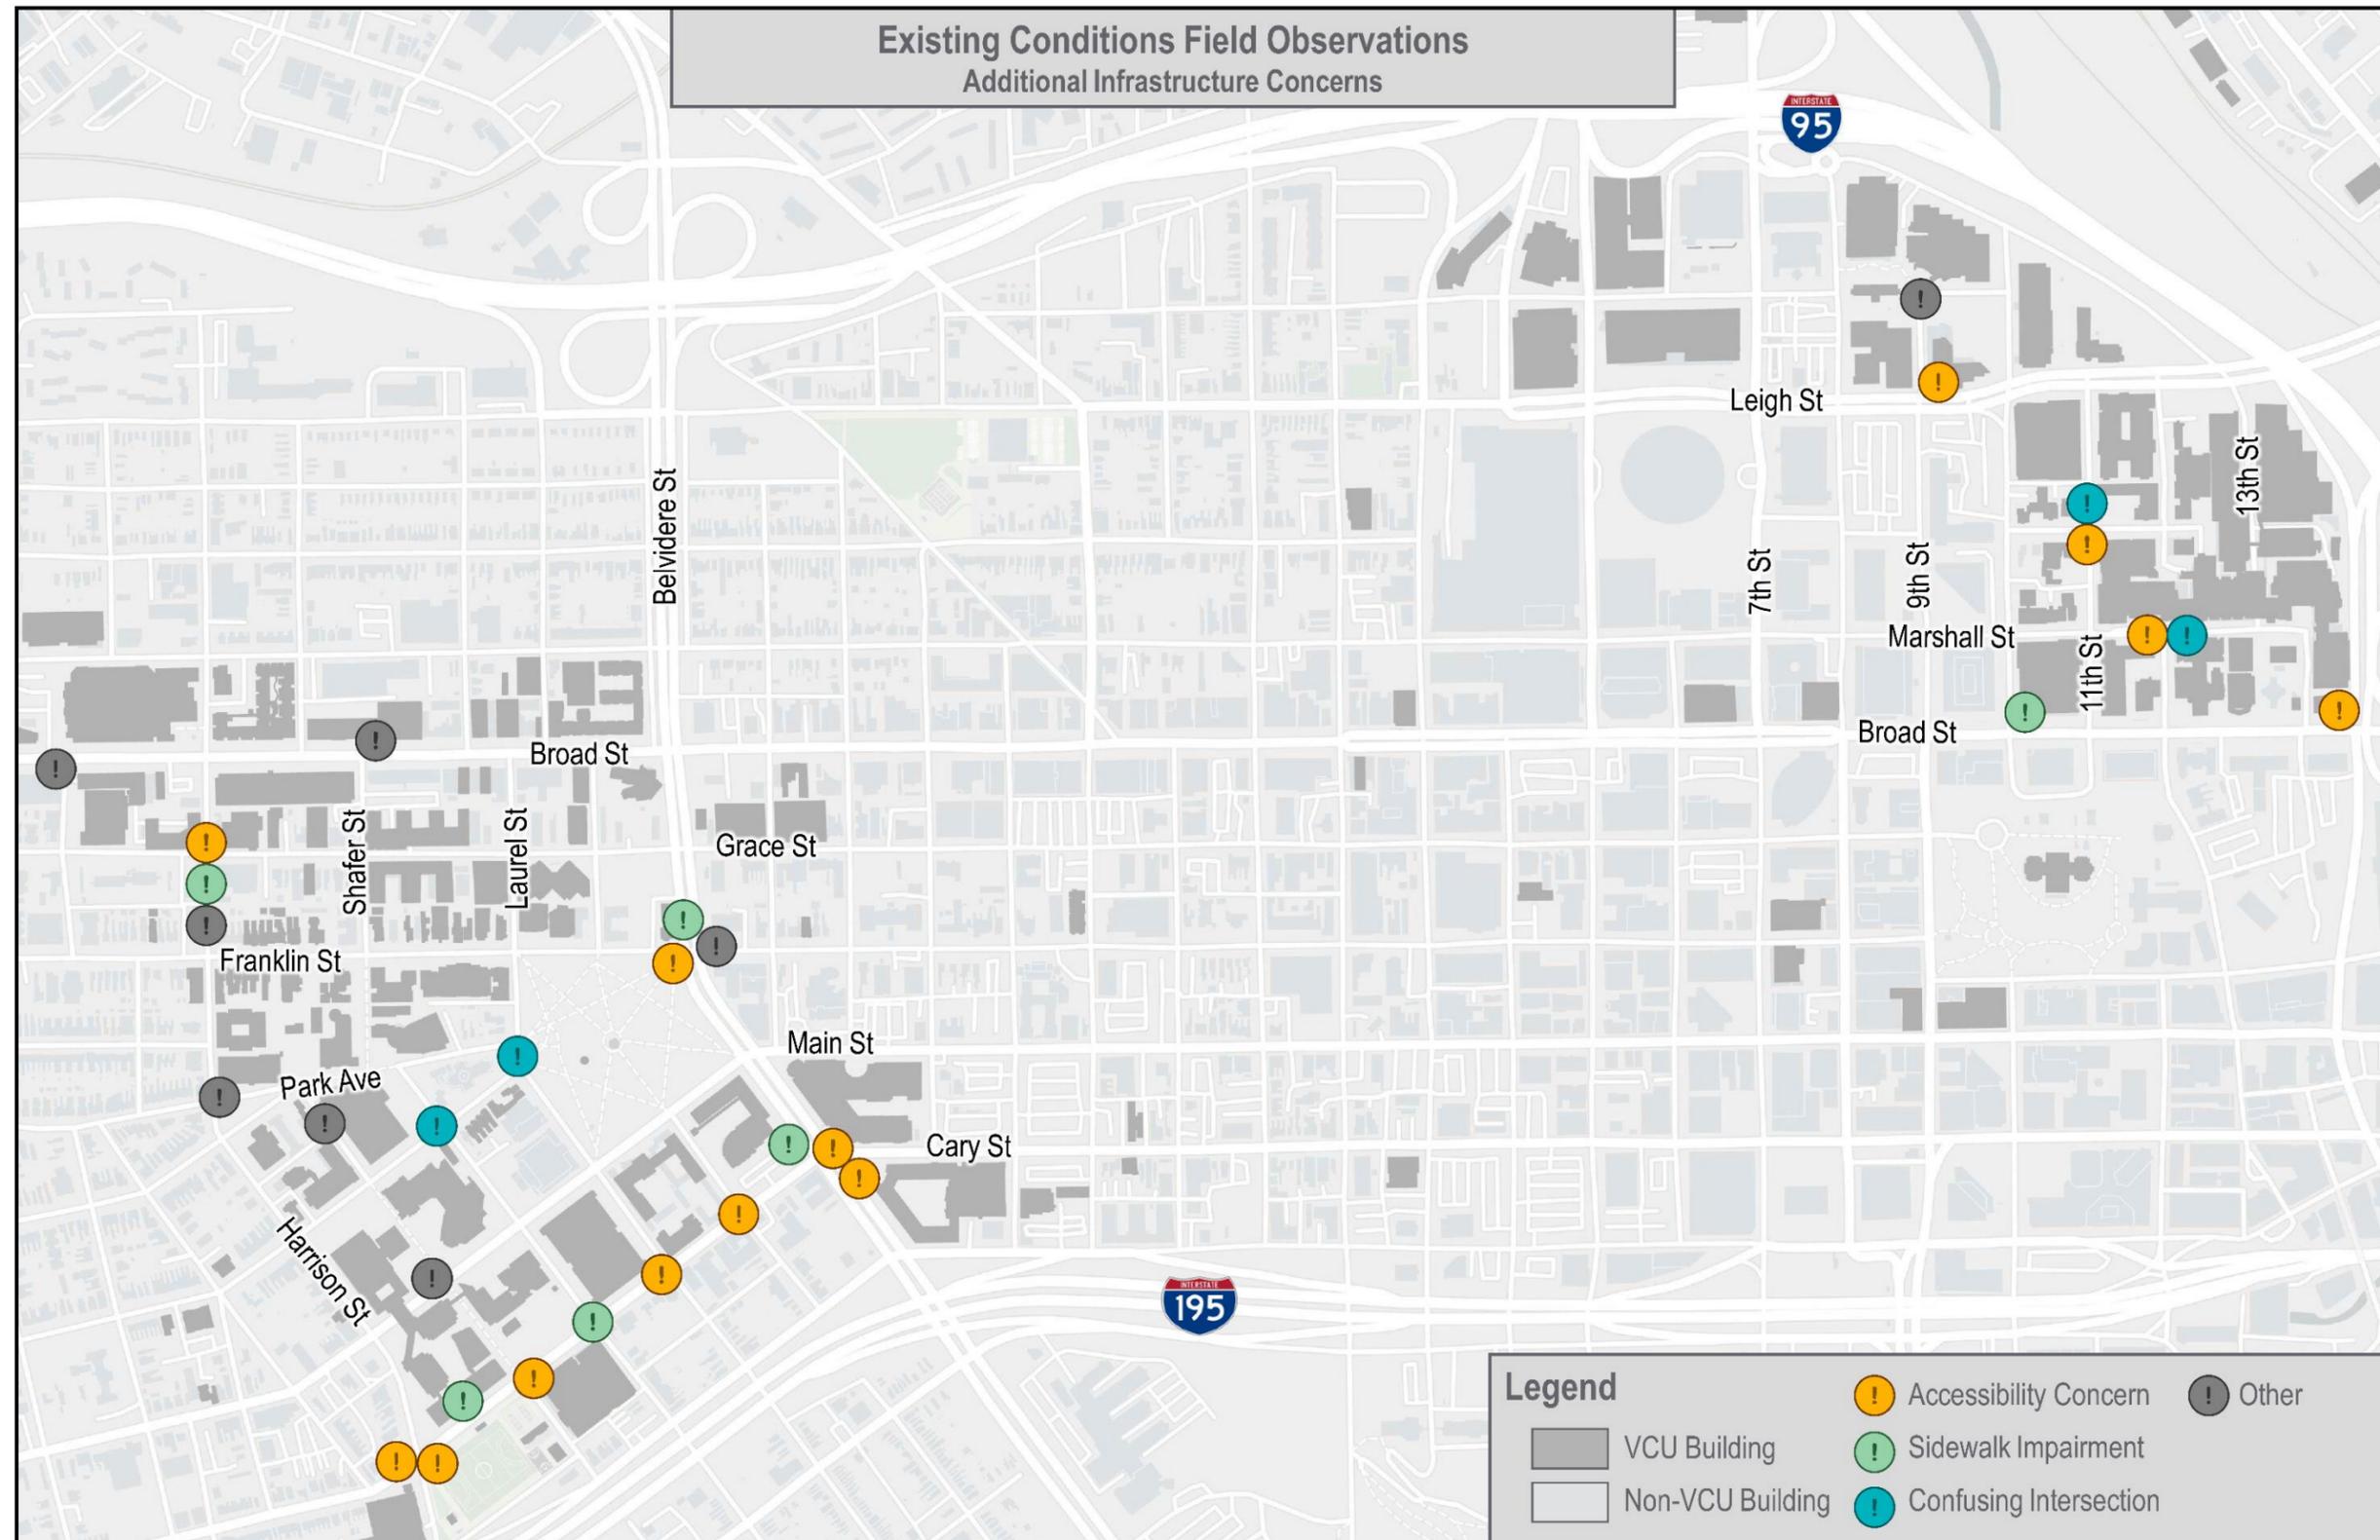
Exhibit A-6: Additional Infrastructure Concerns

Providing safe and accessible infrastructure for all pedestrians, including pedestrians that use mobility devices, is essential to improving campus pedestrian safety.

The thirteen yellow icons identify accessibility concerns including inadequate curb ramps or warped pavement within crosswalks that make the pedestrian path less accessible.

The six green icons represent areas with inadequate sidewalks. An obstructed or too-narrow sidewalk may force pedestrians into the road leading to a higher chance of a pedestrian-vehicle conflict.

The four blue icons show where the study team observed confusing configuration and infrastructure. One example the study team noted is traffic signals facing the wrong way on a one-way street at the intersection of Marshall Street and 12<sup>th</sup> Street.

The eight gray icons represent a collection of other unique infrastructure concerns that the study team noted. The study team observed vehicles parking, loading, or otherwise impeding sidewalks and bike lanes. For example, several alleyway entrances along Harrison Street introduce additional conflict points between vehicles and pedestrians. The study team also observed several motorists dropping off students along Main Street near the VCU Student Commons, which created congestion and impaired visibility for motorists and pedestrian at this high pedestrian activity intersection.
